# Whenuapai Wastewater Servicing Scheme Package 2 – Massey Connector and Northern Interceptor Phase 2

## Ecological Impact Assessment

Prepared for Watercare Services Ltd  
Prepared by Beca Limited

29 August 2023

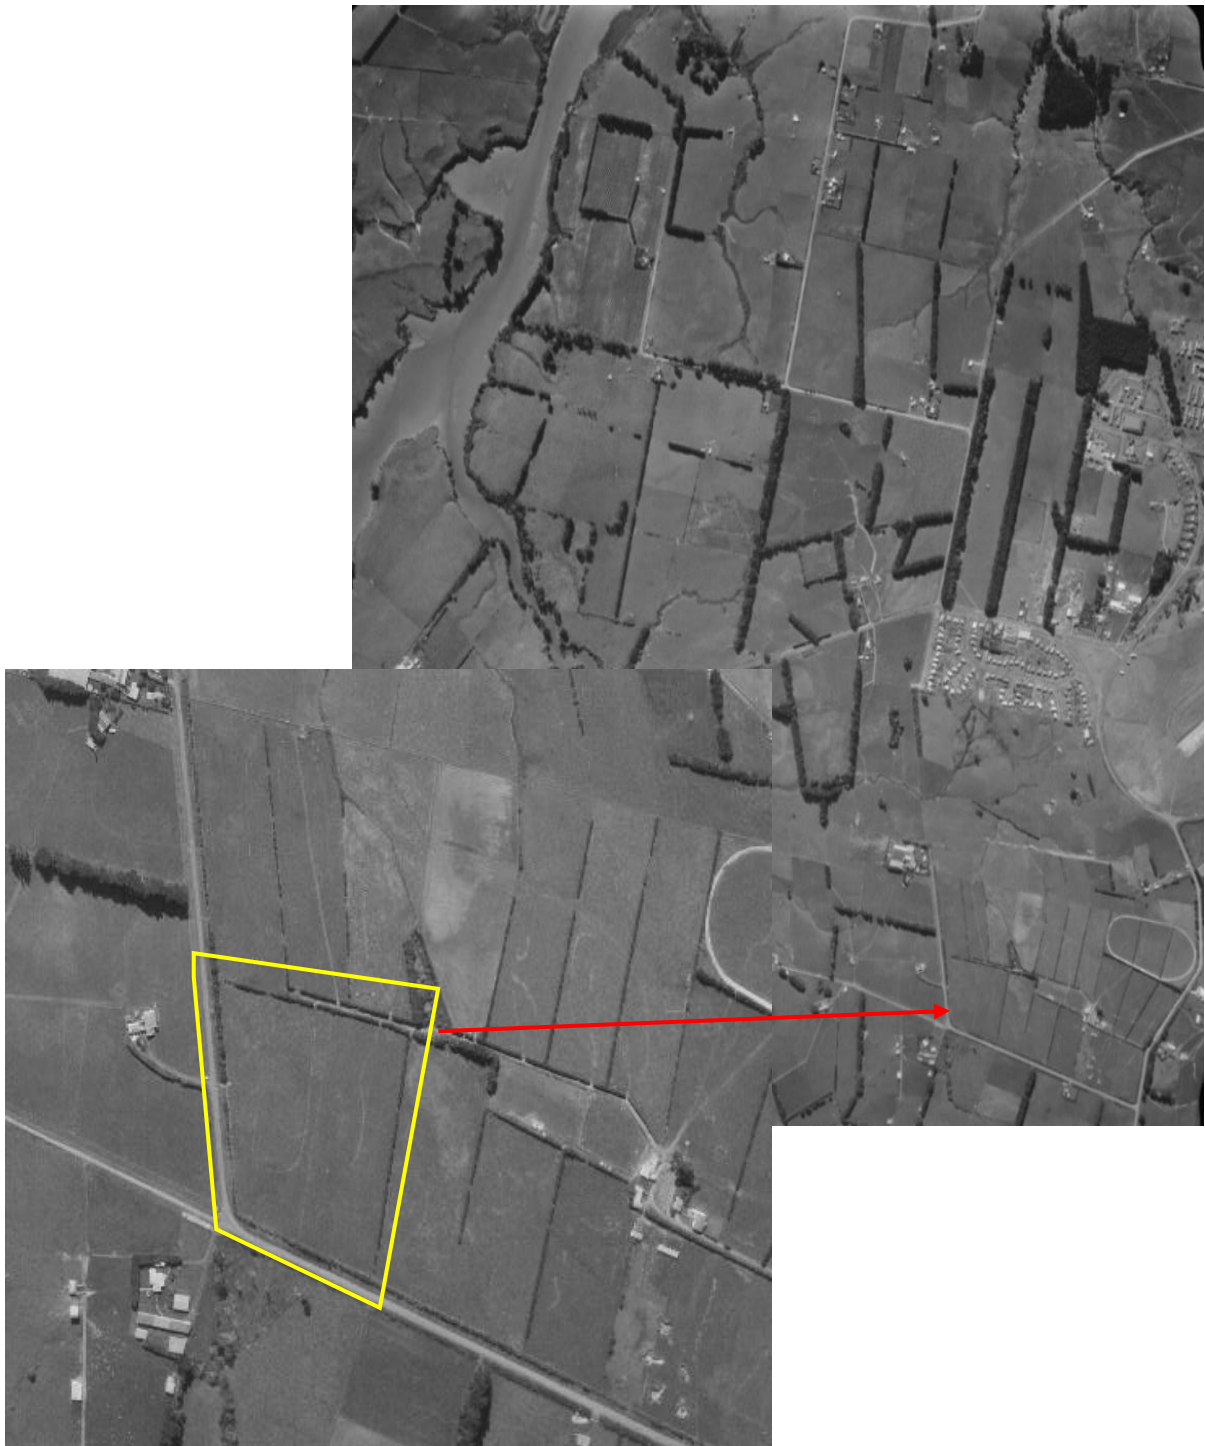
Figure 4. Aerial imagery of the BPC site from 1963. Yellow outline is the property boundary (Source: Retrolens).

Within the BPC site, historical imagery indicates the land has been converted for rural use since at least 1940 and surveying of these images identified no defining features that would indicate that there are historic wetlands or watercourses (Figure 4 and Figure 5). Aerial imagery from Auckland Council Geomaps database indicates that between 2015 to 2017 the land was utilised for crop growth and harvesting, however, presently the land appears to be unused.

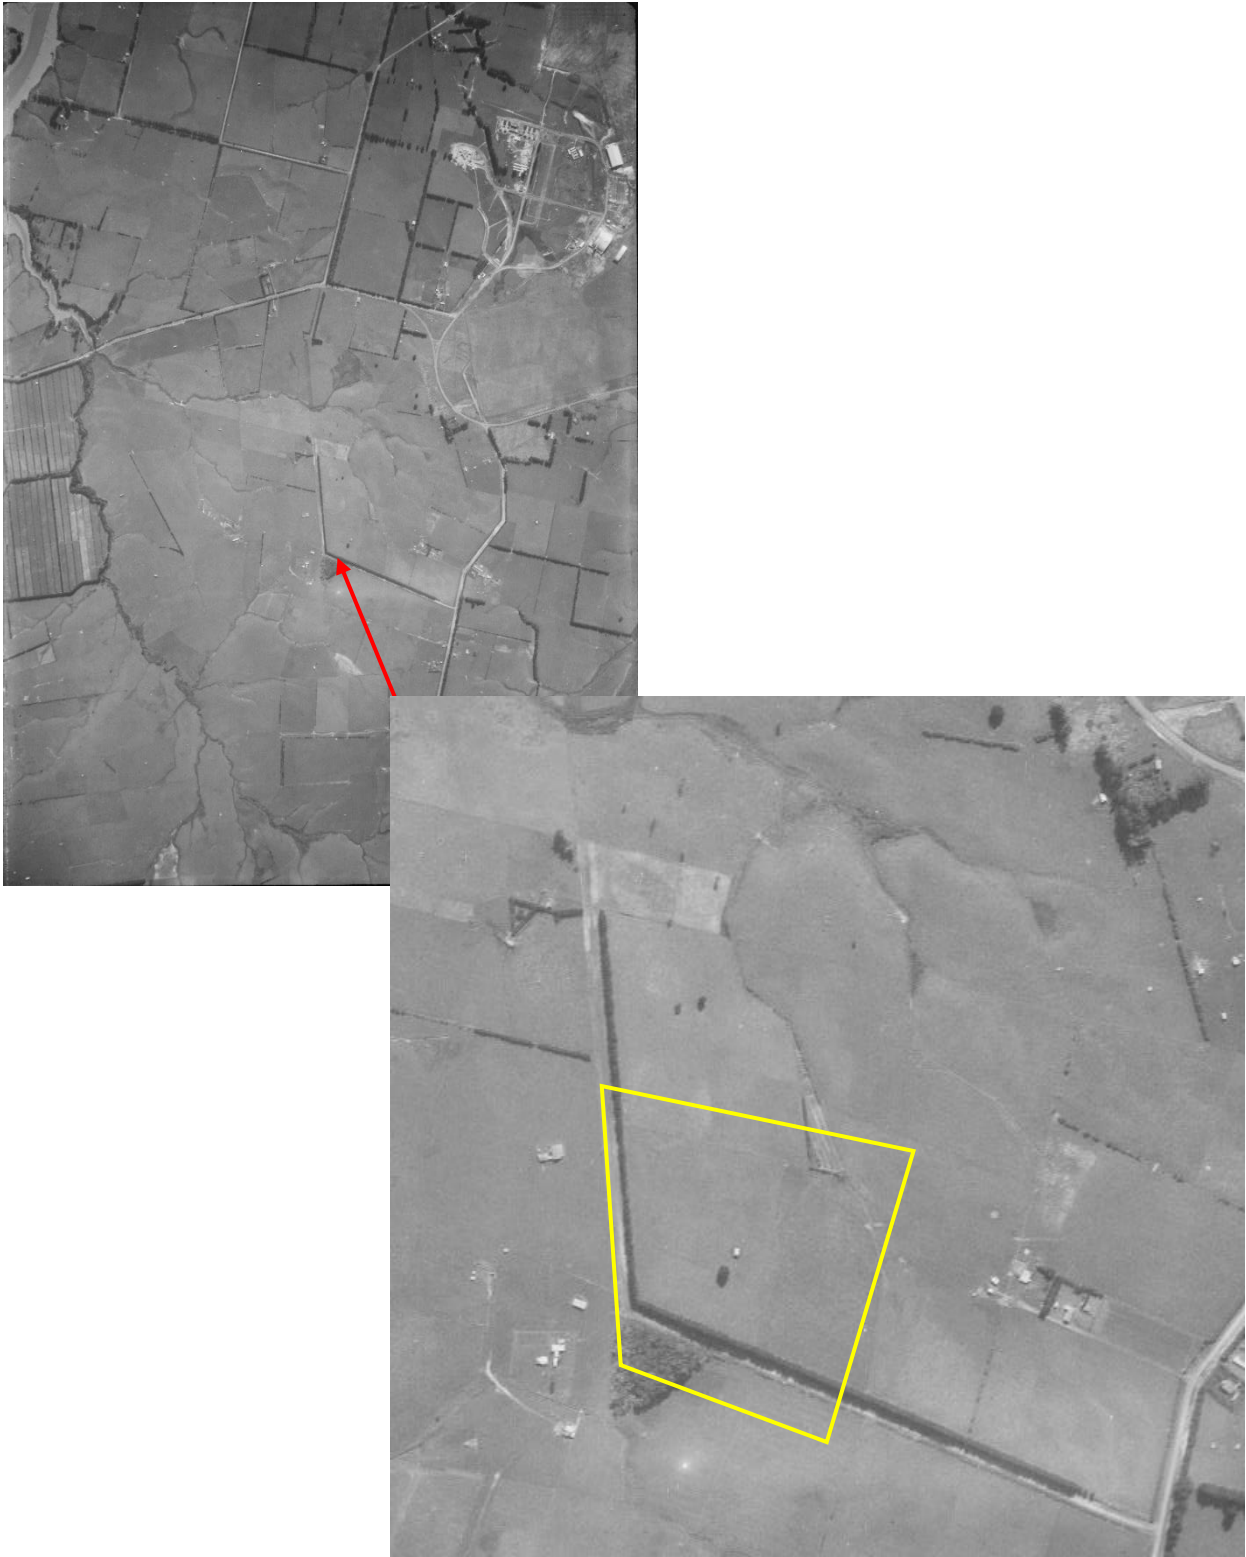
Figure 5. Aerial imagery of the BPC site from 1940. Yellow outline is the property boundary (Source: Retrolens).

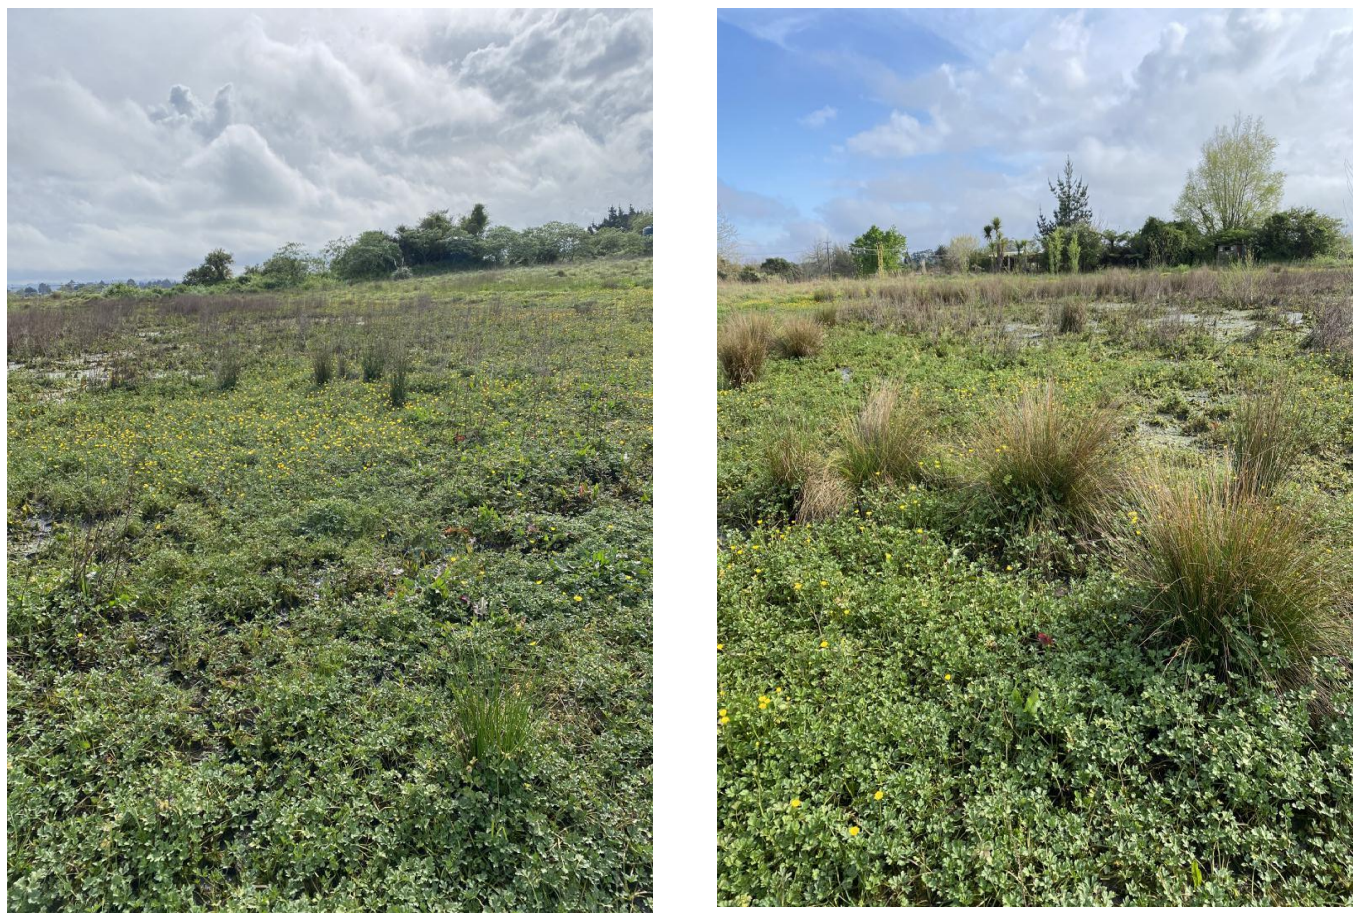
Figure 6. Vegetation communities identified within the northern section of the BPC site (22/09/2022).

The northern section of the site is located in a slightly lower-lying area in comparison to the southern section (approximately 1 m) as indicated in the available topographic desktop map. As a result of this, it is likely that the northern section will receive more surface water flows during high precipitation events. This slight change in elevation is expected to be the main factor in vegetation differences observed between the northern and southern portion of the property. The northern portion of the property had overall lower species diversity with mainly creeping buttercup (*Ranunculus repens*) and soft rush present, with areas of bare and boggy ground (likely due to recent rainfall) (Figure 6).

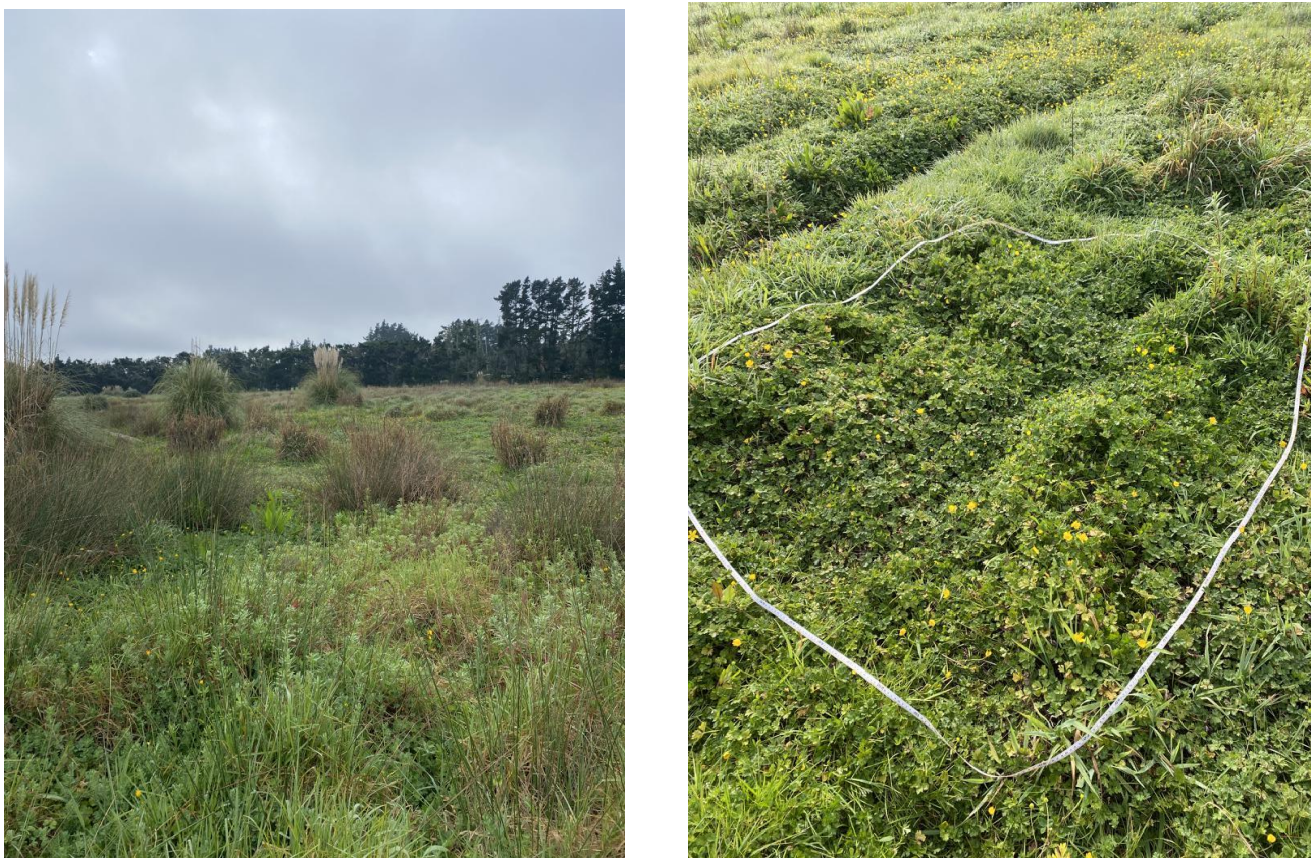
Figure 7. Vegetation communities identified within the southern section of the BPC site (22/09/2022).

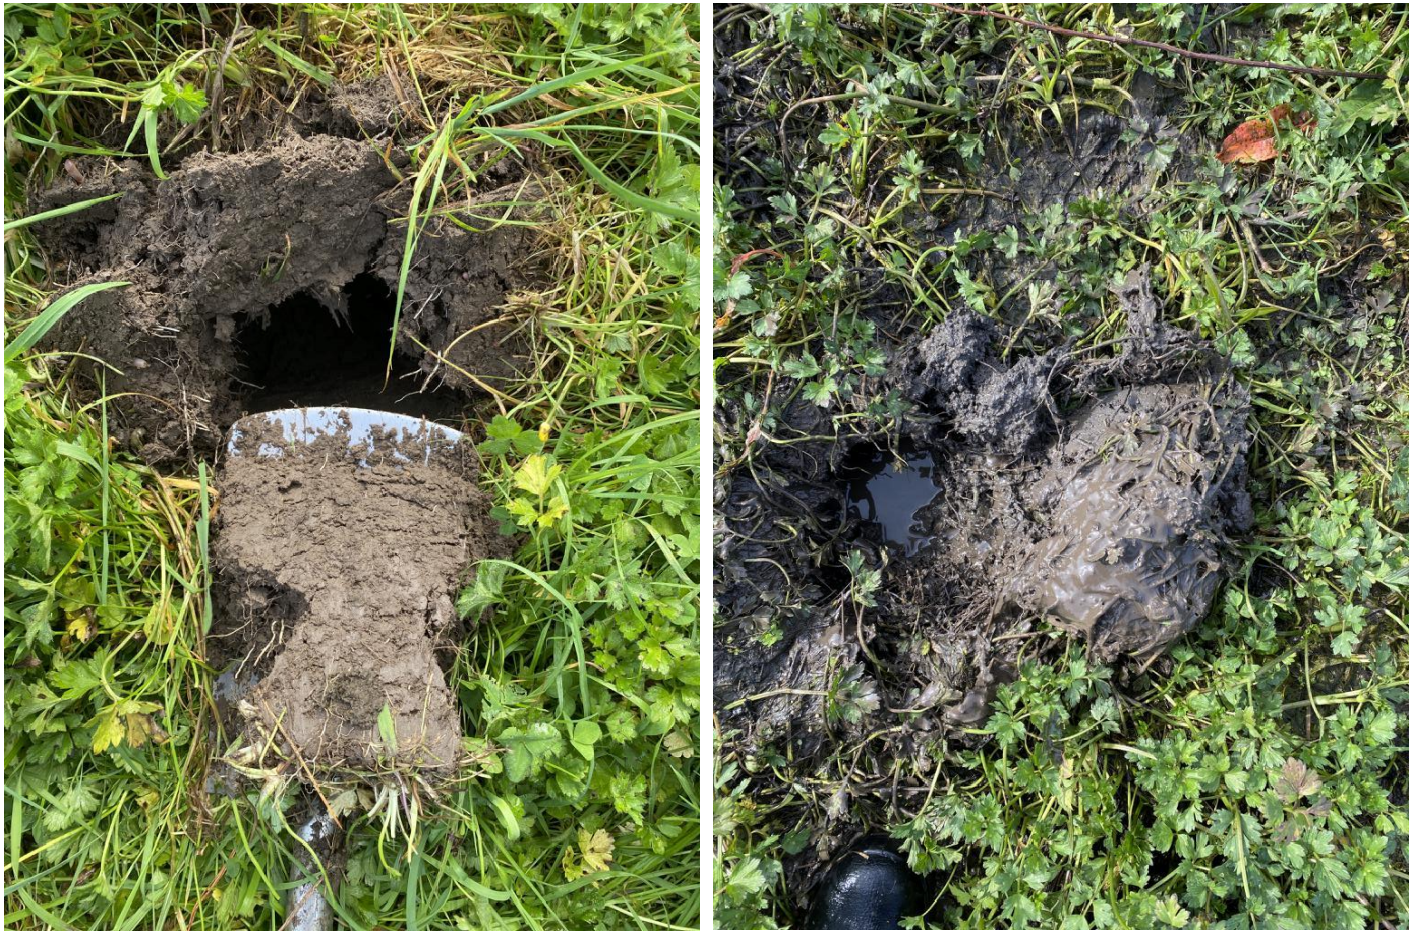
Figure 8. Typically soils identified in the northern section (left) and the southern section (right) where a seasonal perched water table was observed.

Shallow soil investigations were carried out as part of the WDP throughout the site and results found typically non-hydric soils (high chroma, high organic content, and silt-sand based), which is typical for pasture-dominated landscapes (refer to Figure 8).

Soils within the northern section of the property were highly saturated and a high-water table was observed upon digging the test pit, which immediately filled with water (Figure 8). This is likely indicative of either a high or perched groundwater table, which is expected during the winter season (Mott MacDonald, 2022). Soil composition is mainly comprised of sandy silt with minor clay components and a high chroma. The highly saturated soils observed during the soil investigations is likely due to the moderate rainfall events experienced during the days prior, as well as due to the generally high rainfall events experienced throughout the Auckland region over the 2022 winter period.

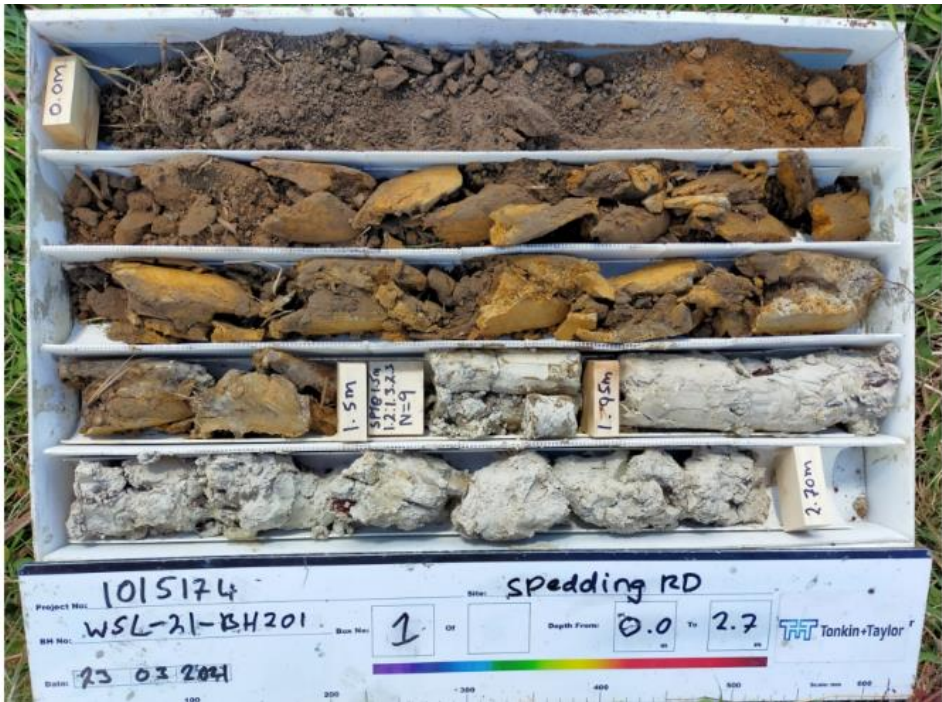
Figure 9. Borehole assessment carried out at the southern section of the BPC site. Results displayed to a depth of 2.7 m.

Bore-hole logs from within the southern section of the BPC (Figure 9) indicate that between 0 – 2.7 m below ground soil types consist of mainly silt, silty-clay, and sandy-silt. The soil is described as moist within the first 2.7 m and transitions from high chroma to lighter orange/brown to depths of 1.5 m. The reason for this transition is:

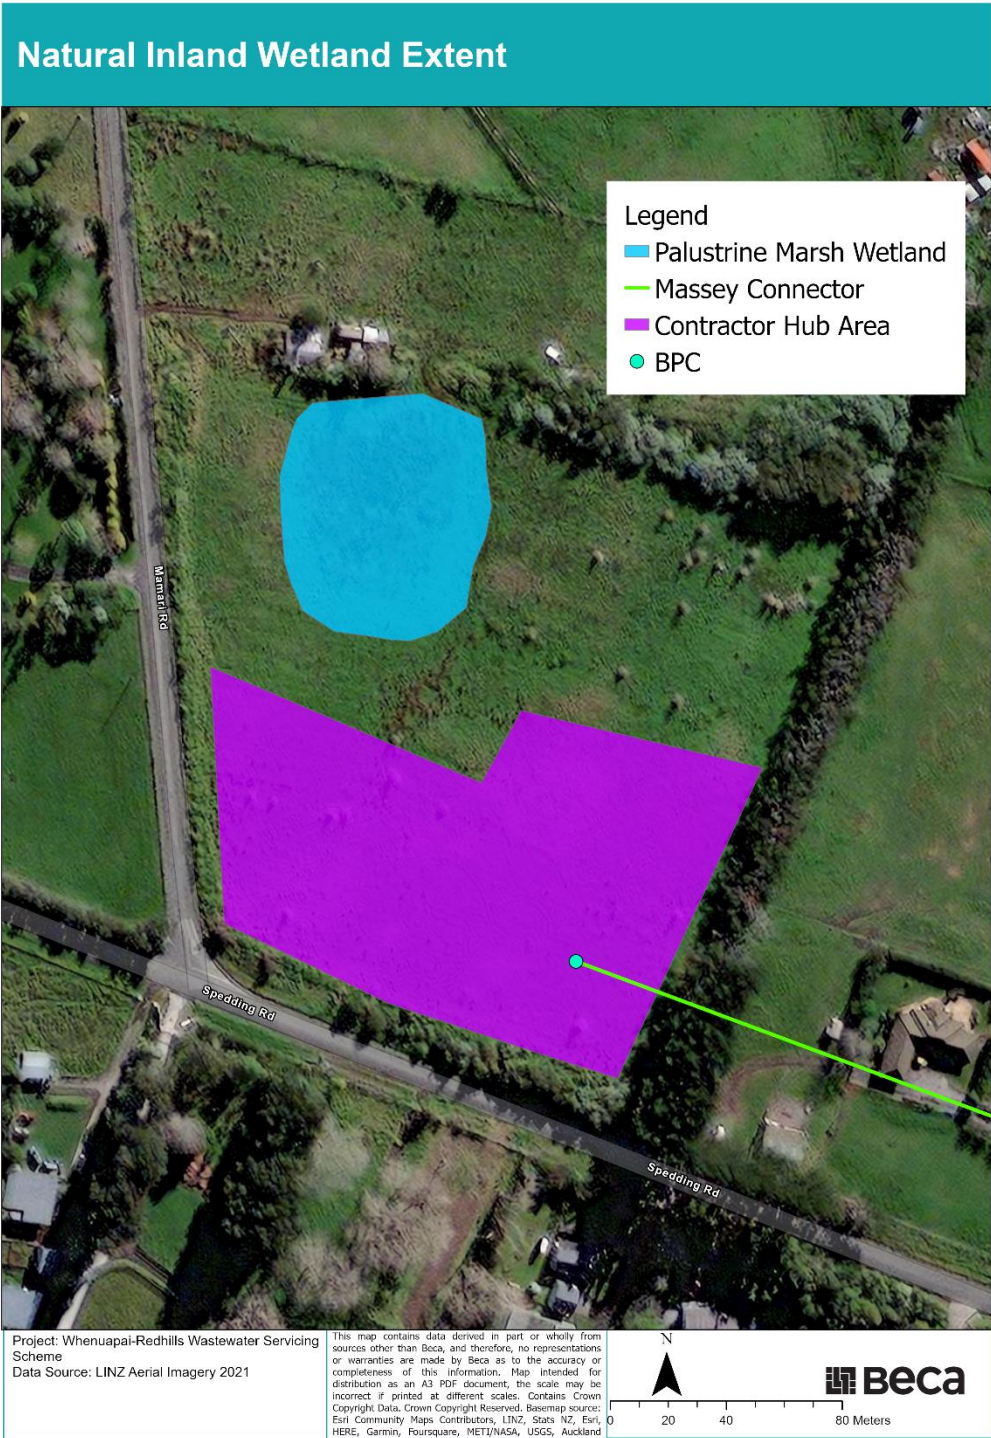
Figure 10. Delineation and extent of the palustrine marsh wetland identified on the northern area of the BPC site.

Taking into consideration the results of the vegetation, soil, and hydrology tests, the wetland system is considered to be ephemeral or intermittent, and it is likely that seasonal variation in rainfall leads to ponding

in the lower lying sections of the landscape during the wetter months and completely dries out during the drier months (Johnson & Gerbeaux, 2004b).

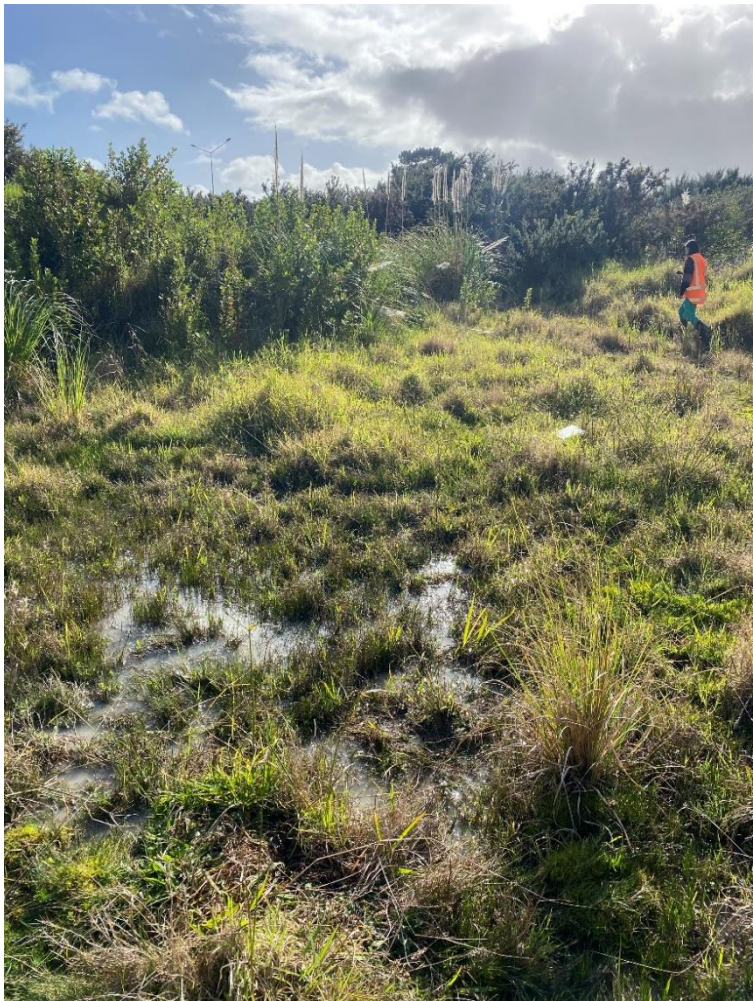
Figure 12. Vegetation and ponded water identified within the depressed zone at Shaft 8.

The species with the highest percentage cover was jointed rush (*Juncus articulatus*). Other species identified in much smaller percentage cover and scattered throughout included umbrella sedge (*Cyperus eragrostis*), creeping bent (*Agrostis stolonifera*), and spearwort (*Ranunculus flammula*) (Figure 12).

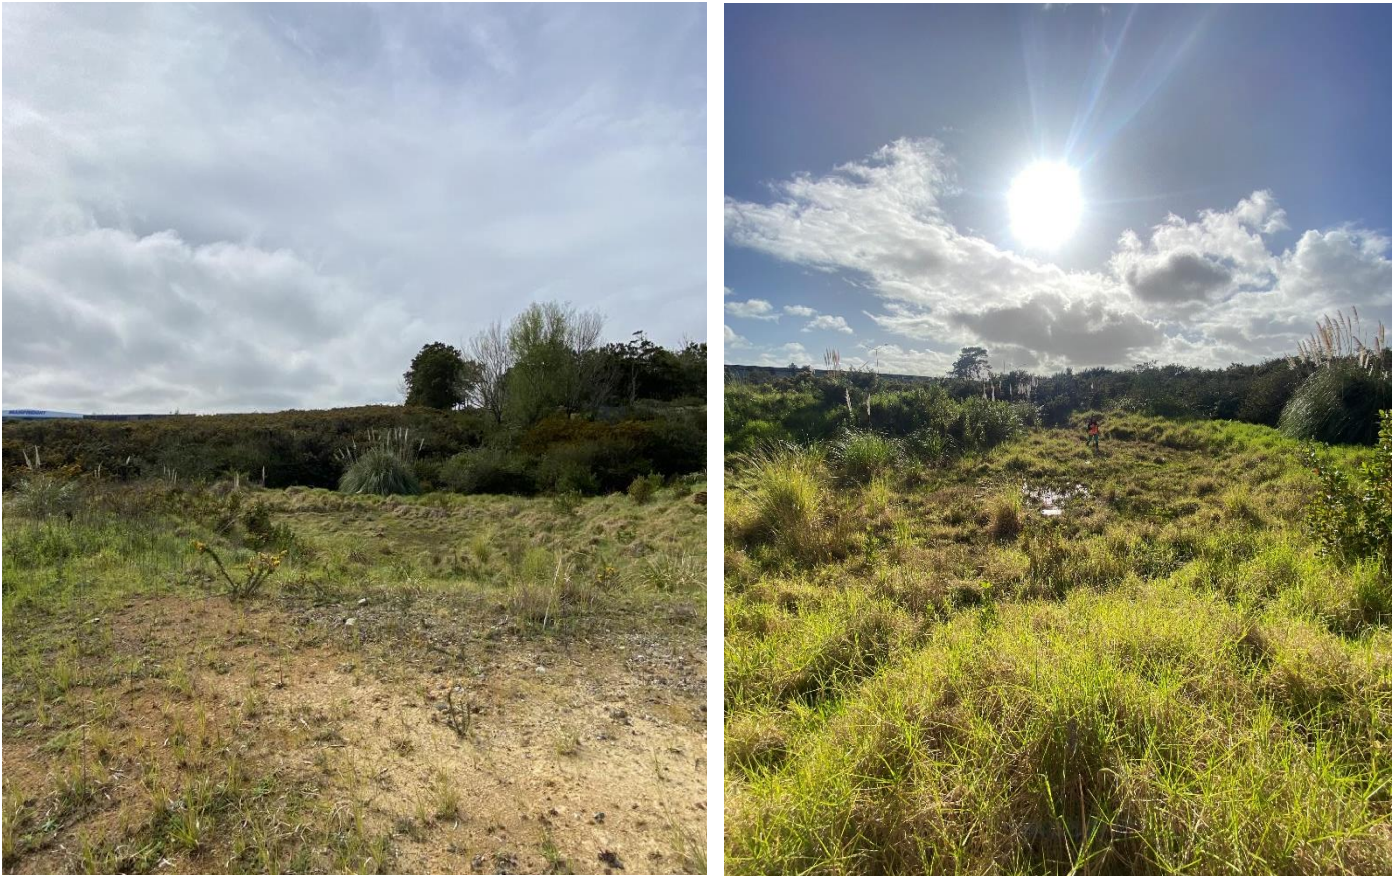
Figure 13. Comparisons of Shaft 8 between September 2022 and July 2023 indicates the site has been highly influenced by the high rainfall events experienced throughout the Auckland (particularly north Auckland) region since January 2023.

However, due to the high rainfall events recorded for the entire Auckland region over the last 6 – 7 months, the hydrology tests are considered to be unreliable, especially when comparing these results to the observations made onsite during the first site visit. As such, professional judgement has been applied here and it is highly likely that the wetland hydrology features observed during the second site survey has been influenced by the recent high rainfall events, and as such, is not considered to be “normal conditions” of this area.

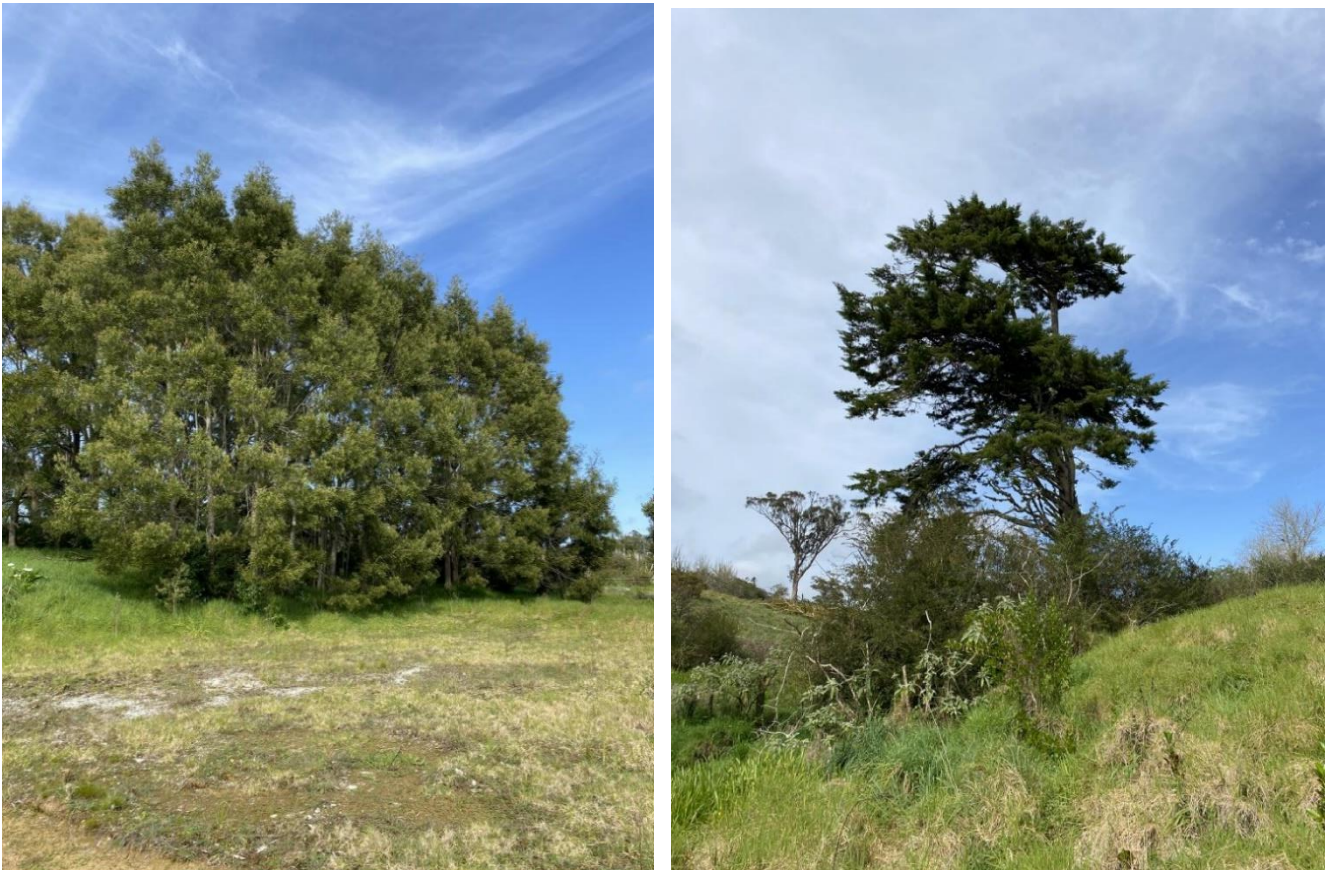
Figure 18. Terrestrial vegetation identified at Shaft 8.

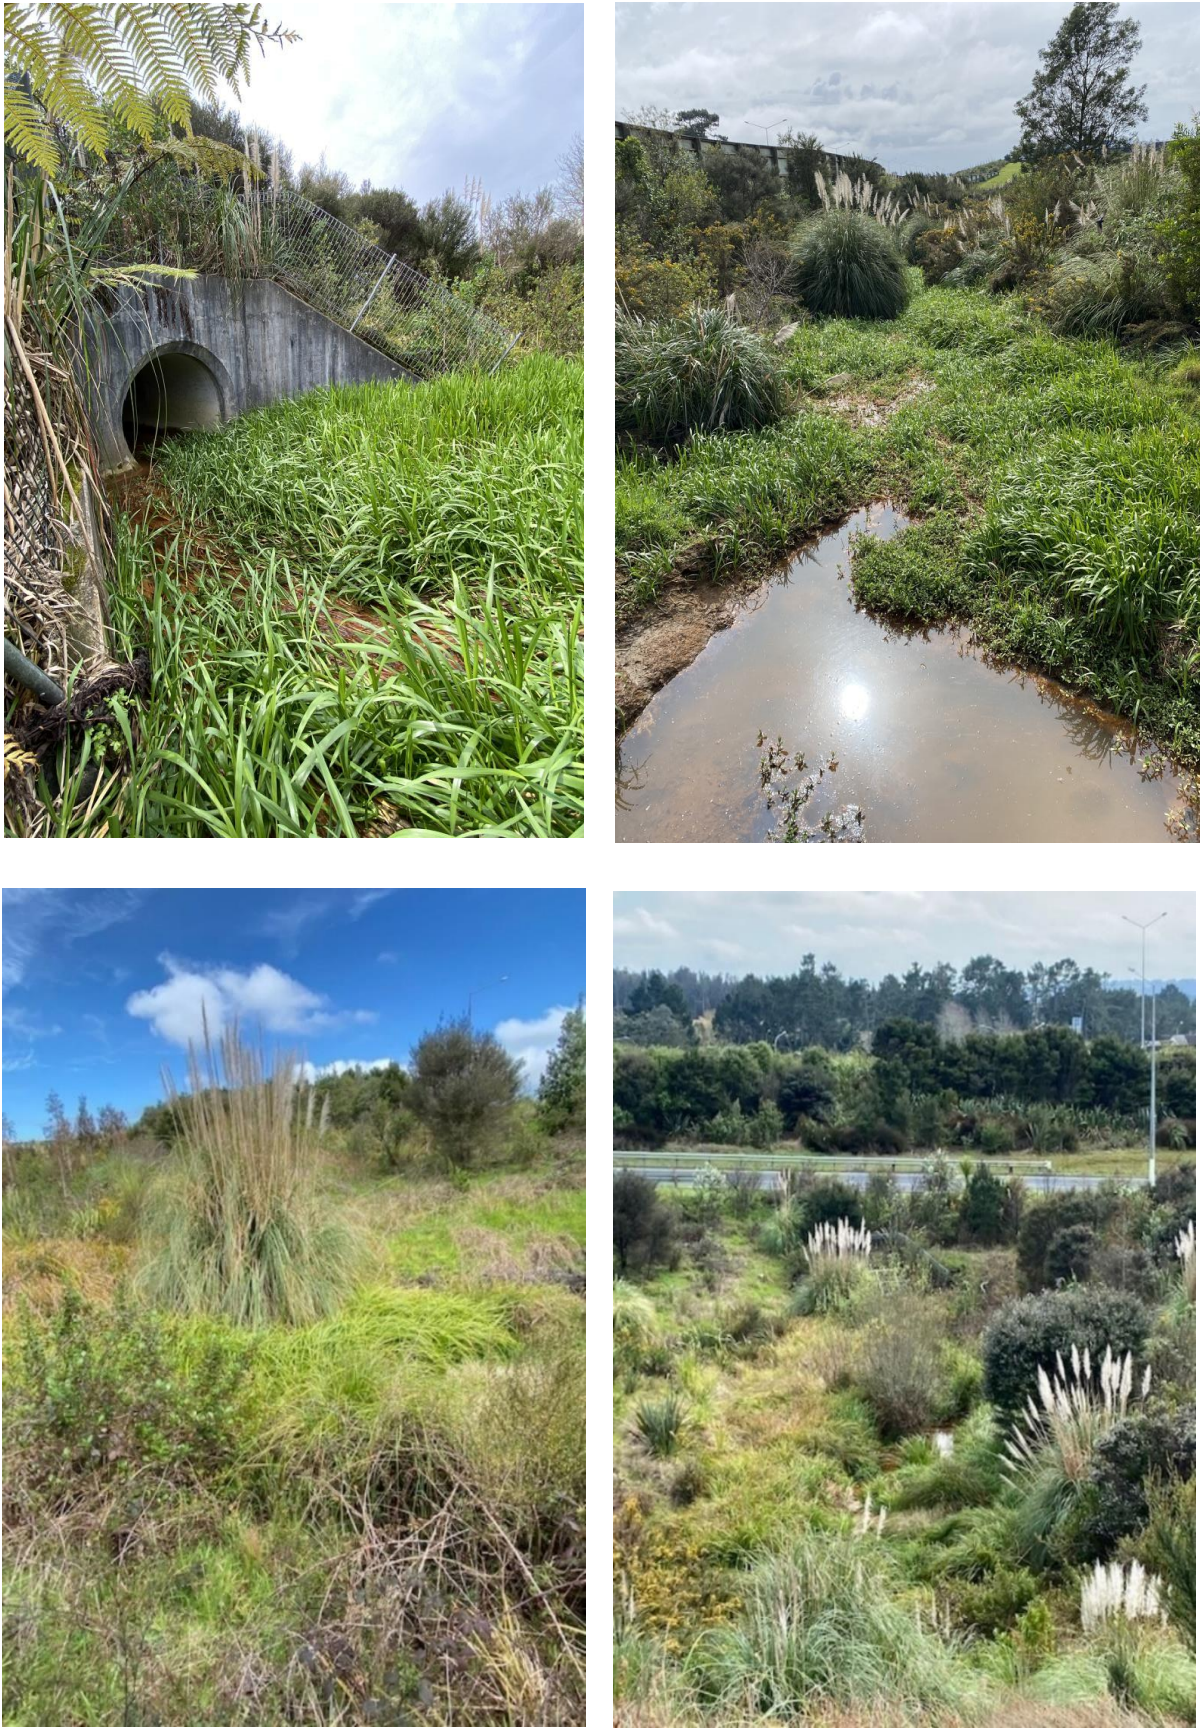
Figure 19. Riverine wetland systems identified within the project area at Shaft 8 (top) and Shaft 12 (bottom).

There are several moderate-sized sections of riverine wetland associated with both the Waiarohia and Trig Stream channels. The flowing watercourse has allowed for the establishment of reed sweet grass alongside the Waiarohia Stream channel and within the channel, as well as along the terraced bank of Trig Stream. This species is an exotic obligate wetland species found in aquatic habitats including drains and slow flowing waterbodies. Additionally, this species is a pest plant in Auckland and is known to aggressively grow and spread, often forming dense mats in nutrient rich areas and limiting the growth of native macrophytes and providing limited habitat to native aquatic fauna (Figure 19).

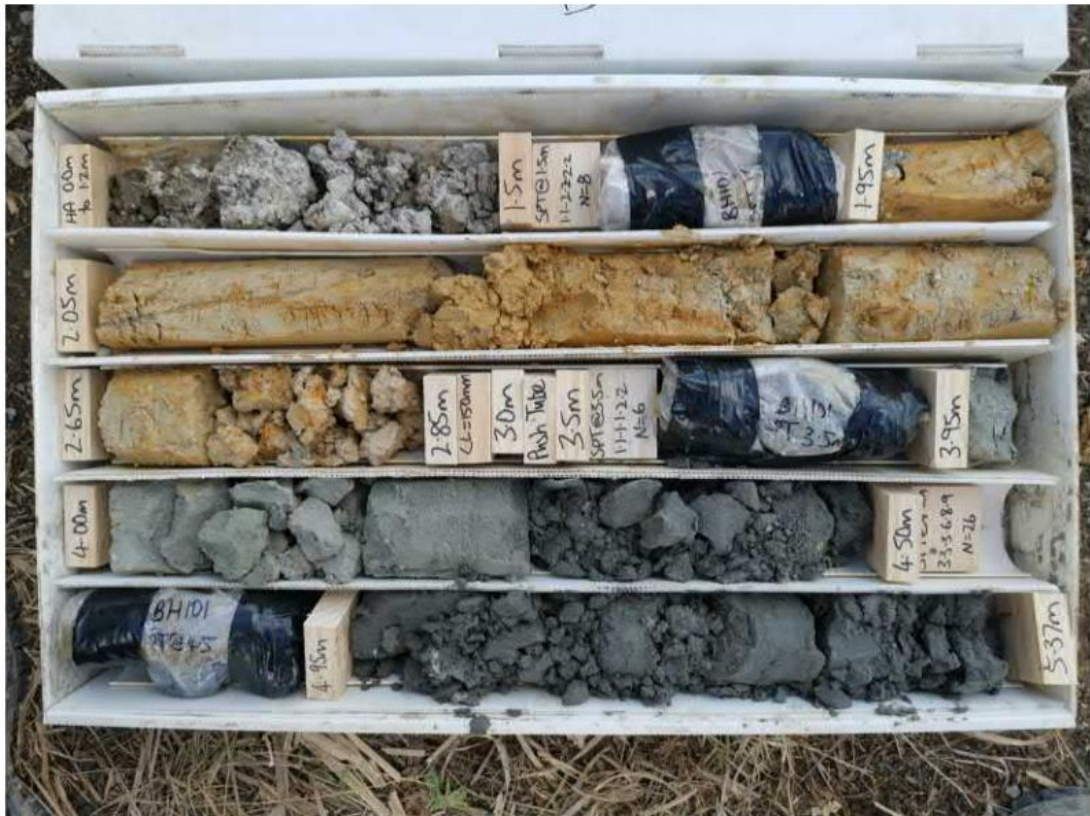
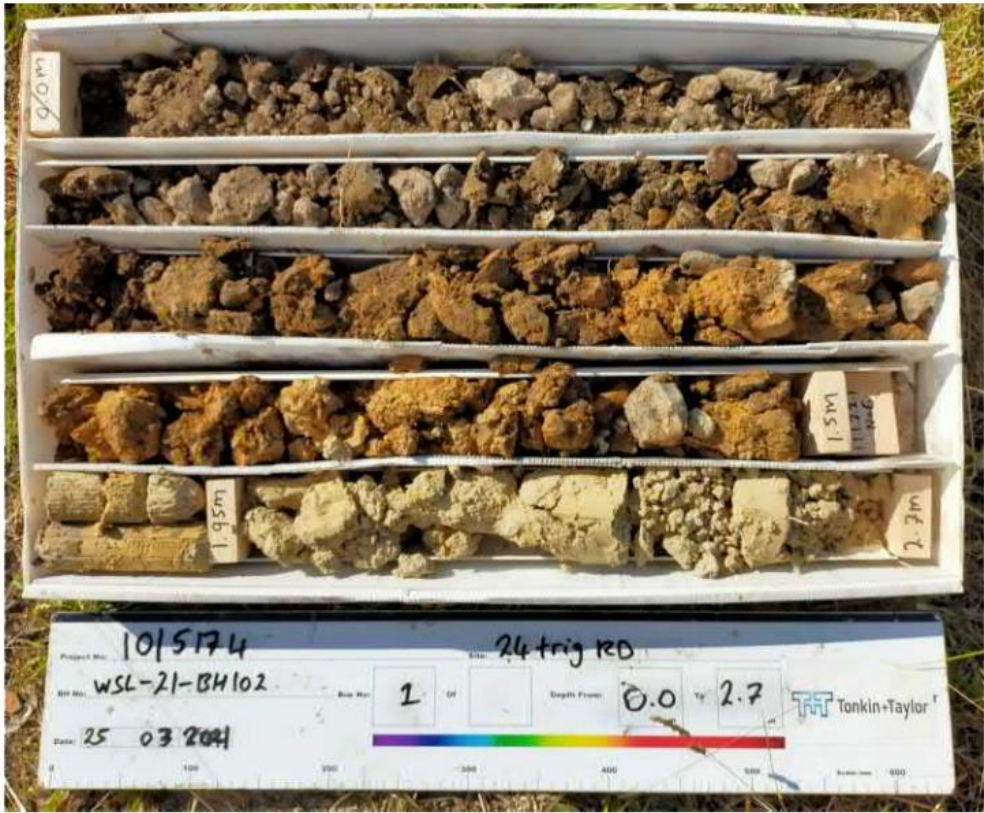
Figure 4.1. Borehole logs from the proposed location for Shaft 8, including Borehole 1 (bottom) and Borehole 2 (top).

As such, Borehole 1 indicates higher permeability, within the top 1.35 m of the soil, with a transition to lower permeability material from > 1.35 m. This indicates that the soil has good drainage abilities, and, under normal seasonal conditions, surface water run off, and direct rainwater received by this area should be adequately drained. Borehole 2 has lower permeability within the top 1 m of material indicating less adequate drainage ability, potentially leading to surface water running off and into lower elevation areas.
