# Whenuapai Wastewater Servicing Scheme Package 1

## Ecological Impact Assessment

Prepared for Watercare Services Ltd  
Prepared by Beca Limited

9 November 2023

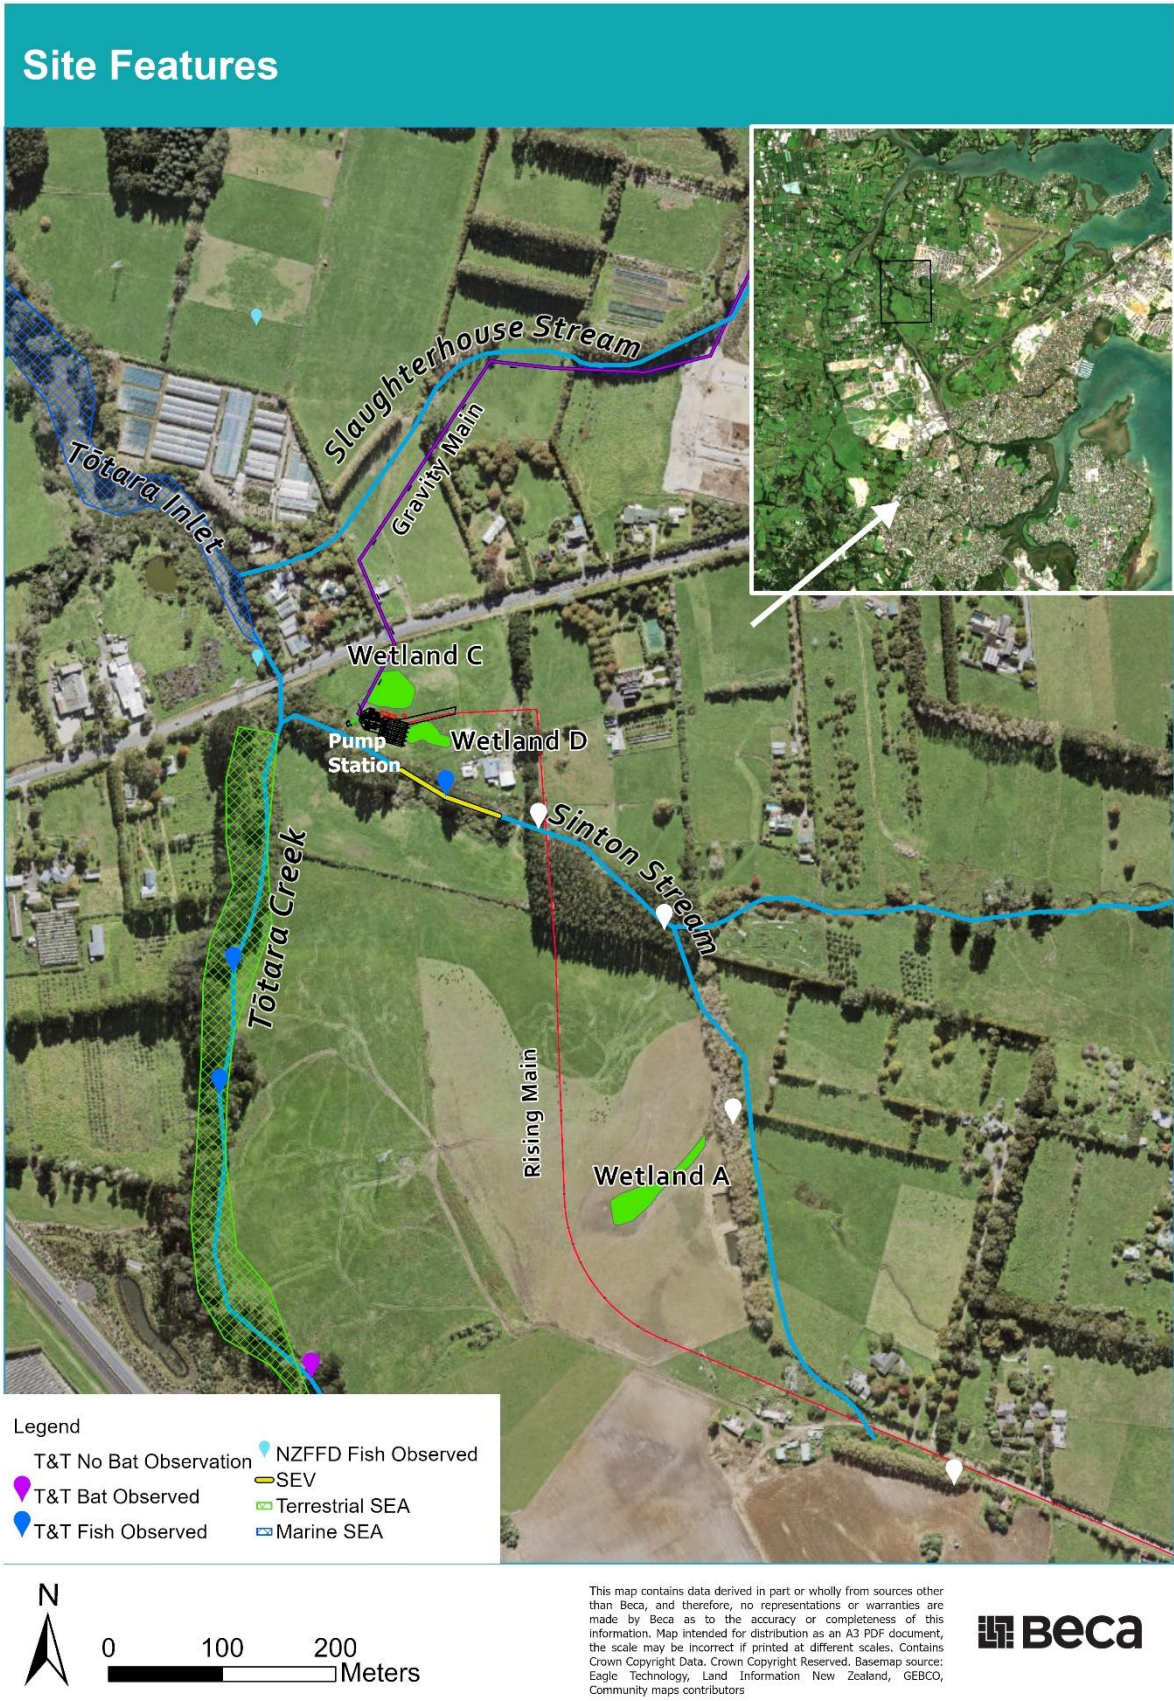
Figure 2: Site in relation to surrounding landscape features and fauna alongside gravity main, pumpstation, and rising main alignment.

The Site (refer Figure 2) is located in the suburb of Whenuapai, Auckland on the northeast border of the North-Western motorway. It sits within the Tamaki Ecological District which was historically characterised by taraire and pūriri forest, but has been subject to extensive vegetation clearance and landform modification for urban use over time (McEwen, 1987). Prior to any development, the Site would have been covered by a mixture of Pūriri forest (WF7), and Kauri, Podocarp, broadleaved forest (WF11) (Singers & Rogers, 2014). Currently, the site and surrounding land is predominantly pastoral lifestyle blocks.

Sinton Stream flows from east to west across the site, discharging into Tōtara Inlet and into Brigham Creek (refer Figure 2). The downstream reach of Sinton Stream is permanent with water flowing year-round. In-stream habitat heterogeneity is present (i.e., pool, riffle, run habitats). It has a mix of exotic and indigenous riparian vegetation providing moderate shading, including a large stand of pine trees (*Pinus* sp.) (Figure 6). Immediately downstream of the pine stand is a culvert approximately 5.1 m in stream length, identified to be flowing unimpeded through low flow conditions.

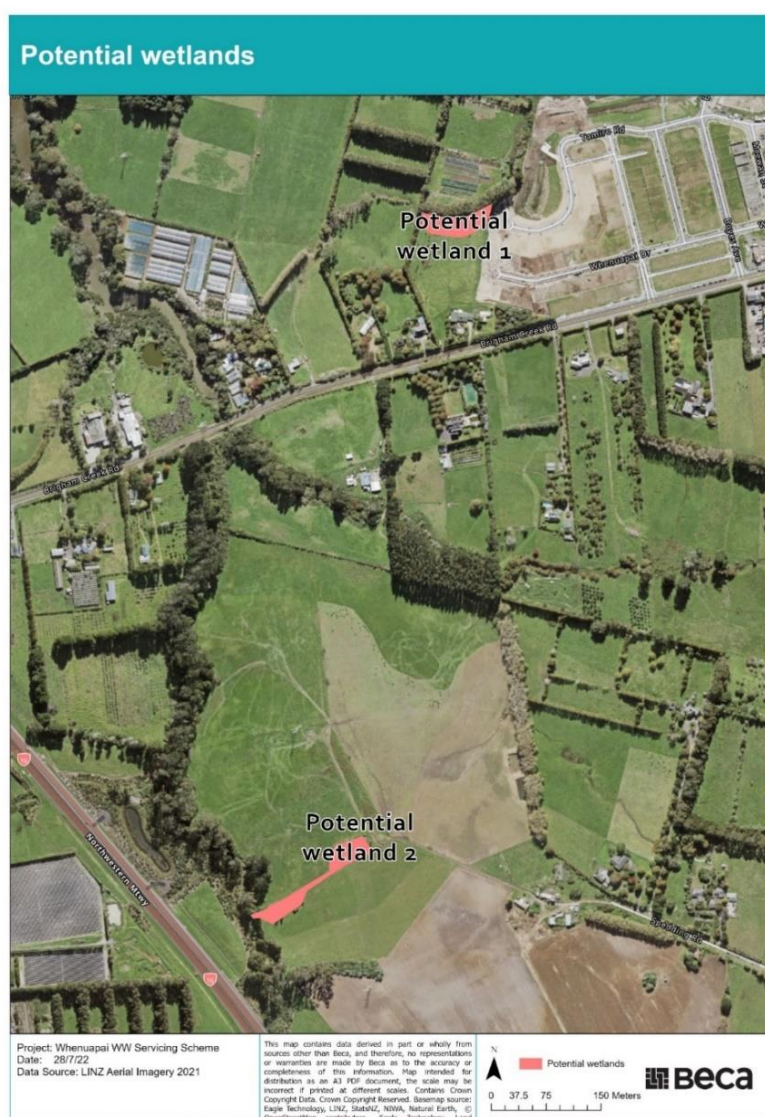
Figure 4. Potential wetland areas identified, investigated during site visit on 5th July 2022.

The two additional potential wetland locations (in addition to those already canvassed by T&T) were identified in the vicinity of the project works via desktop observations as these were observed to be areas of contour depression adjacent to the stream (potential wetland 1) and sloping down towards a stream

These two potential wetland areas are mapped in Figure 4 and were investigated during the site visit in accordance with the methodology described in Section 3.2.2.

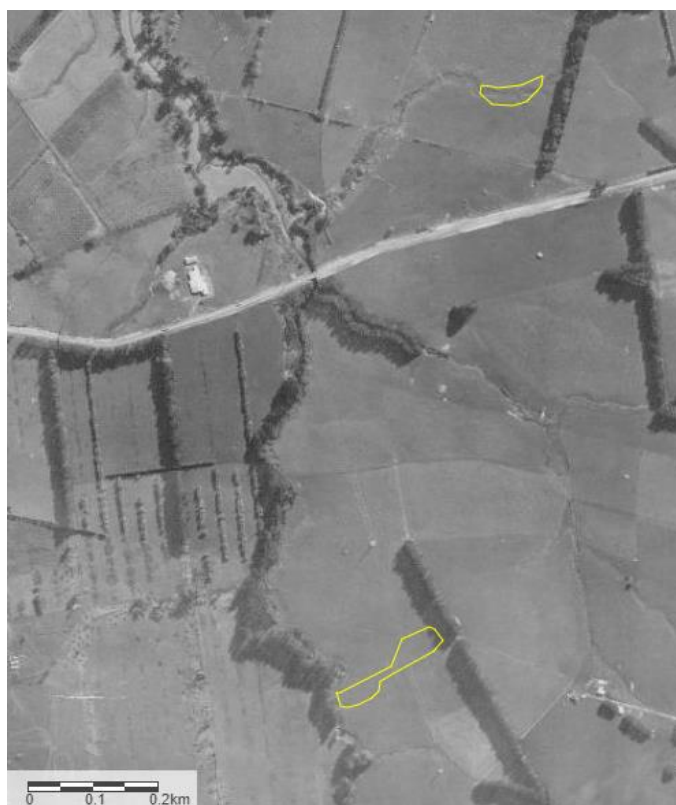
Figure 5. Aerial imagery from 1959 showing approximate locations of potential wetland areas (sourced from Auckland Council Geomaps, accessed 28/7/2022).

Neither of the two areas are modelled as historic wetland (Ausseil et al., 2008; Leathwick et al., 2010). In historic aerial imagery from 1959 (Figure 5). Potential wetland 1 consists of a stream channel and potential adjacent riverine wetland vegetation located within the floodplain. Potential wetland 2 consists solely of pasture in 1959, however since this time the area has been excavated for a silage storage area and drainage channel. This excavation has subsequently formed an area of contour depression.

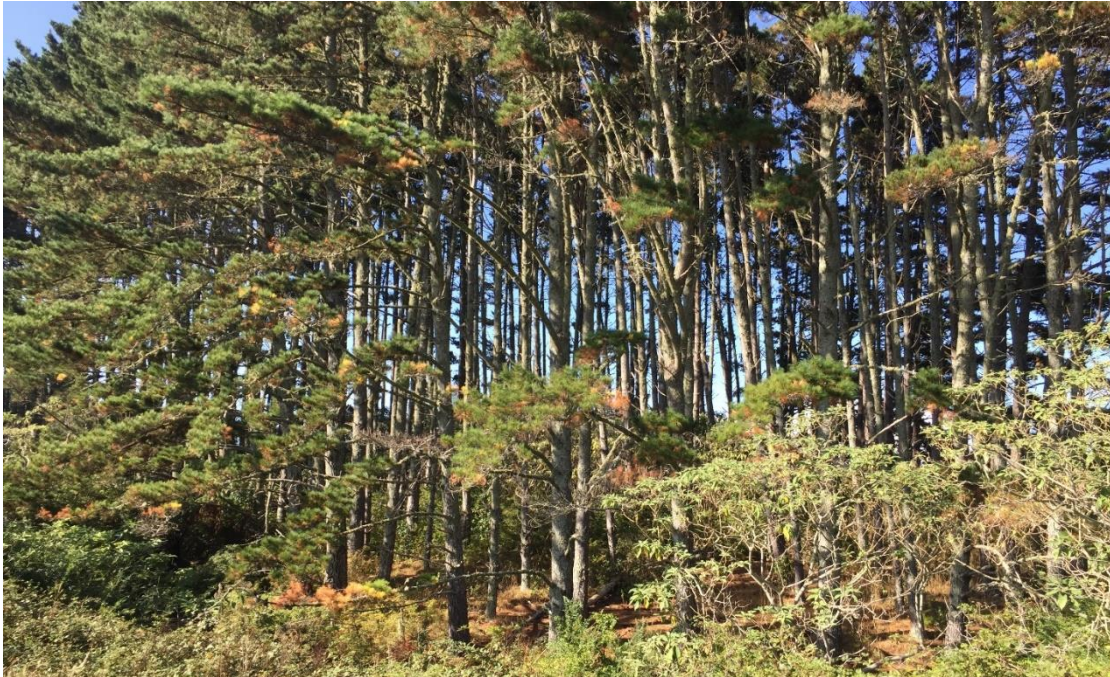
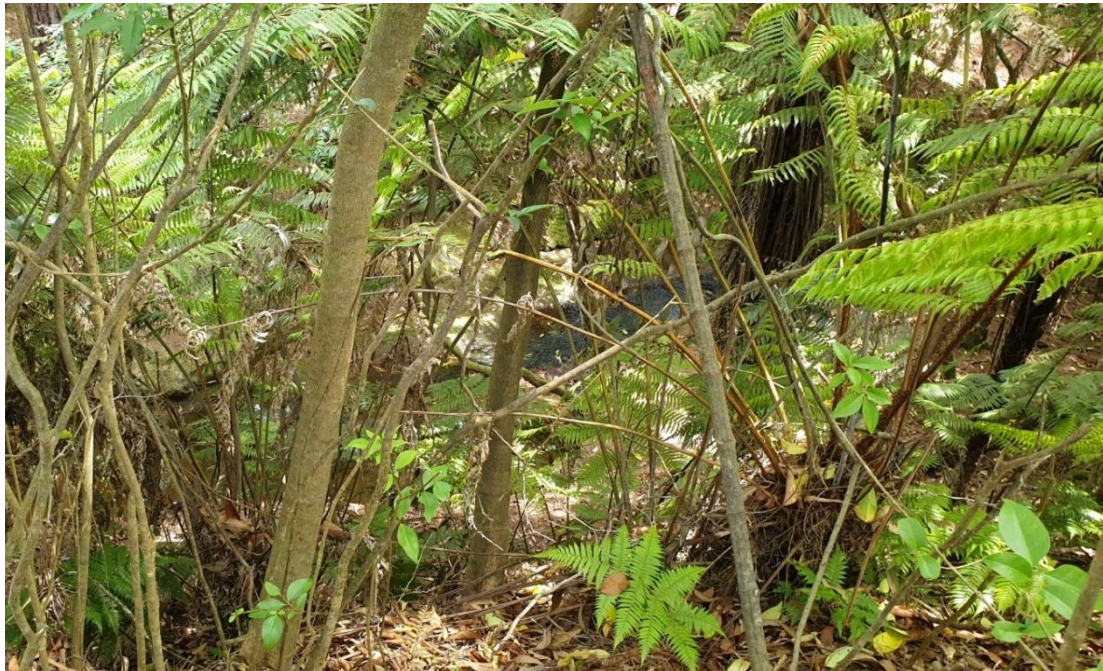
Figure 6. Sinton Stream crossing area pine shelter belt vegetation to be removed (top). Riparian vegetation at the proposed emergency overflow location at Sinton Stream (bottom). Image taken during Beca site visit 3 December 2021.

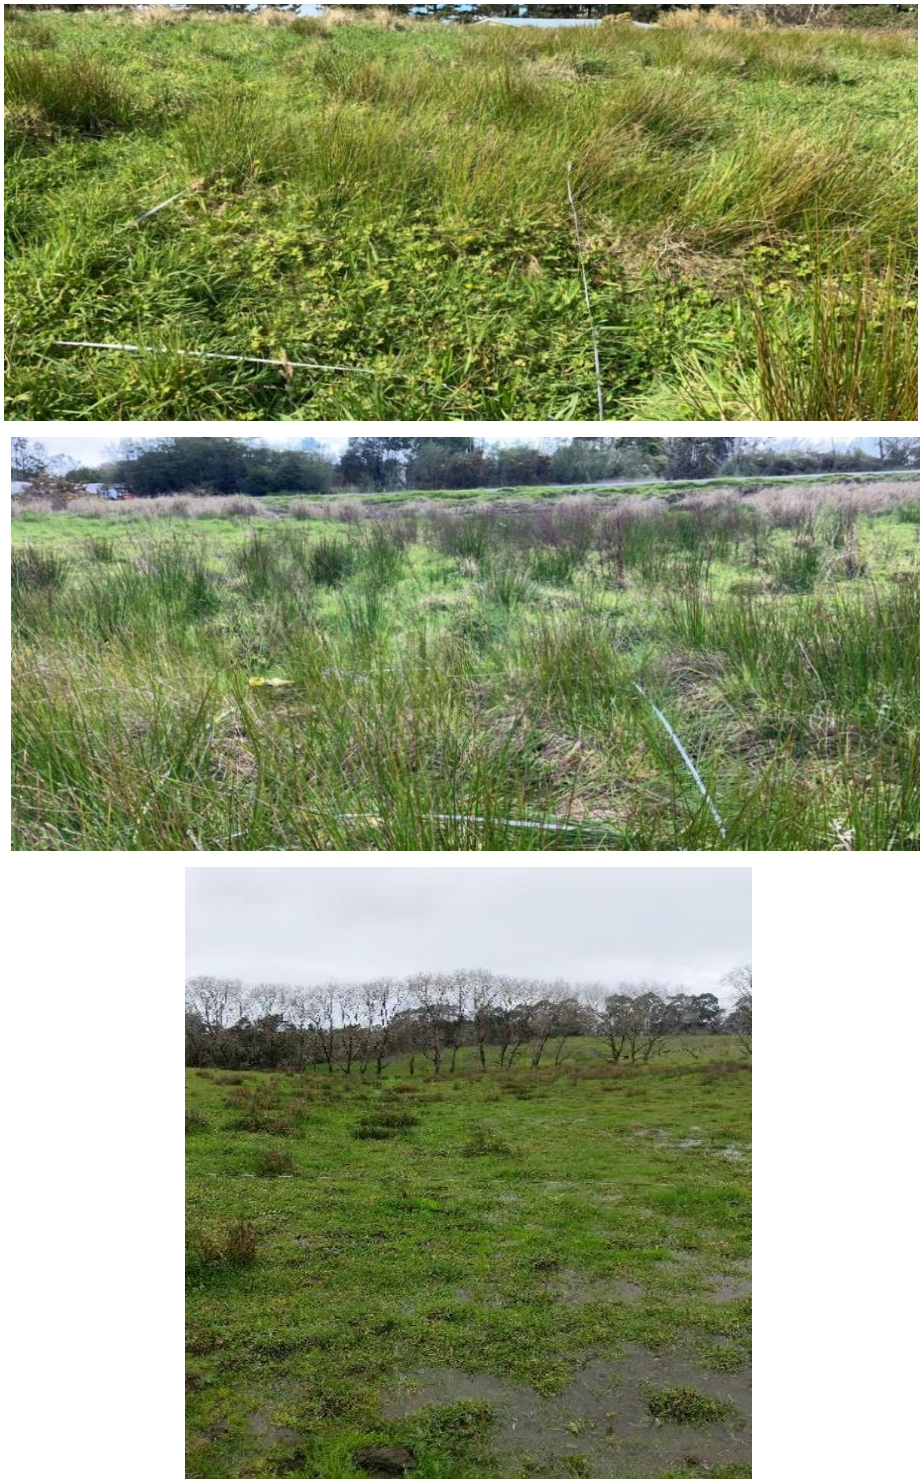
Figure 7. Wetlands identified within the project site. Wetland A (bottom), Wetland C (middle), and Wetland D (top).

Vegetation within the wetland comprises of primarily exotic species and includes soft rush, creeping buttercup, yorkshire fog, and creeping bent (*Agrostis stolonifera*) (Figure 7). Soils were saturated, sticky, and plastic with some mottling and several indicators of hydrology were present. Soil samples were collected at one location (Appendix 5: Figure 5A) and underwent particle size distribution analysis. The results from this indicate that the planting wilting point (PWP) and field capacity (FC) occurs when soil moisture is between 10 – 29%, which would equate to between 20 – 56 mm of water in the soil.

As Wetlands A, C, and D are all similar in terms of characteristics an overall ecological value score has been provided. These wetlands are dominated by exotic species with no Threatened or At Risk vegetation identified, they are located in highly modified environments which has led to them being degraded pasture wetlands, and they provide little to no suitable habitat for any At Risk or Threatened wetland birds. For this reason, and as supported by the assessment undertaken by T+T, these wetlands have **Low** ecological value.

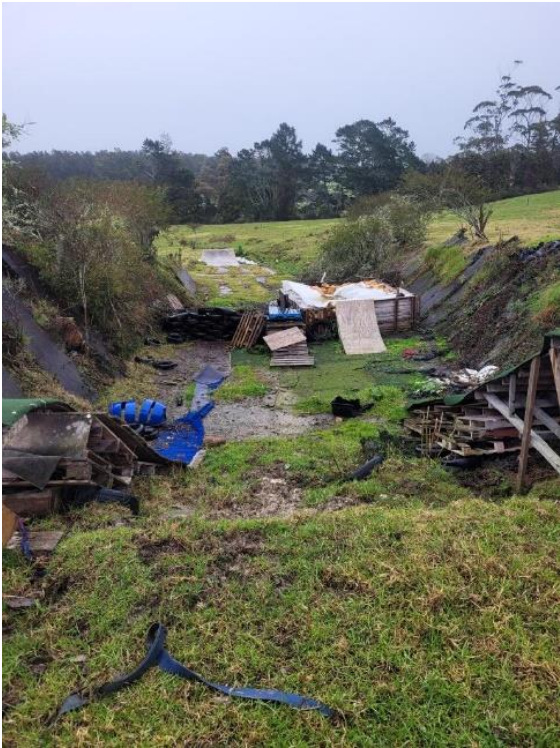
Figure 4b. Image of excavated storage area taken during site visit on 5<sup>th</sup> July 2022.

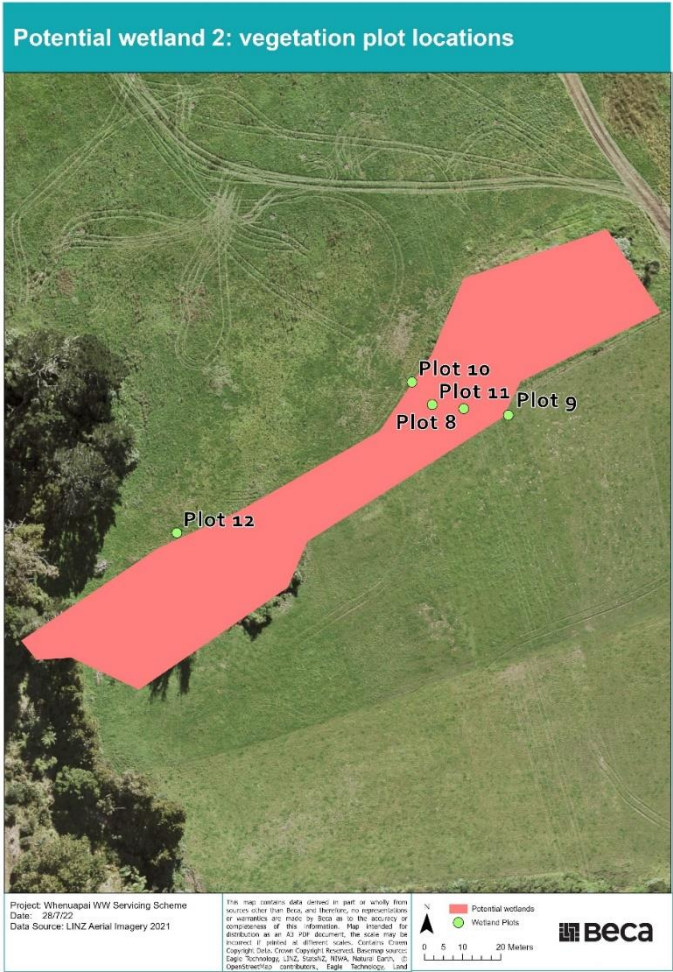
Figure 4e. : Locations of vegetation plots completed within, and adjacent to, Potential Wetland 2.

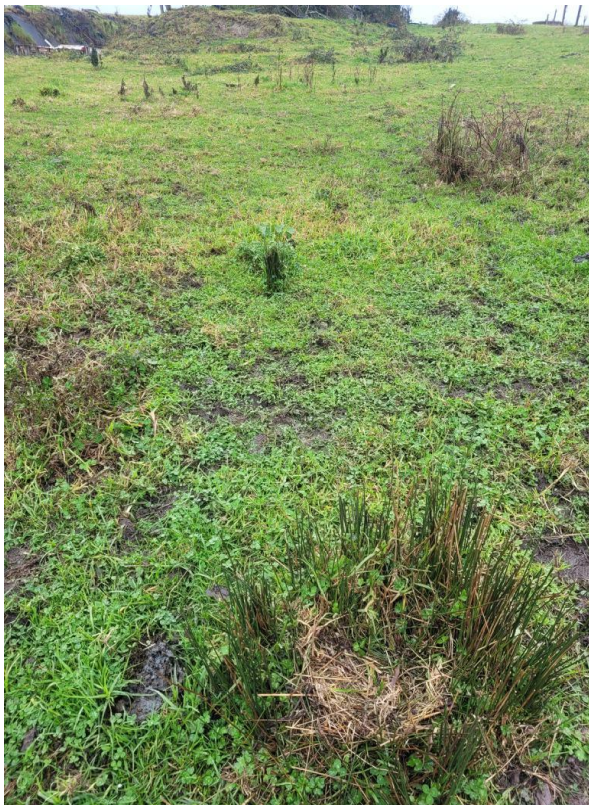
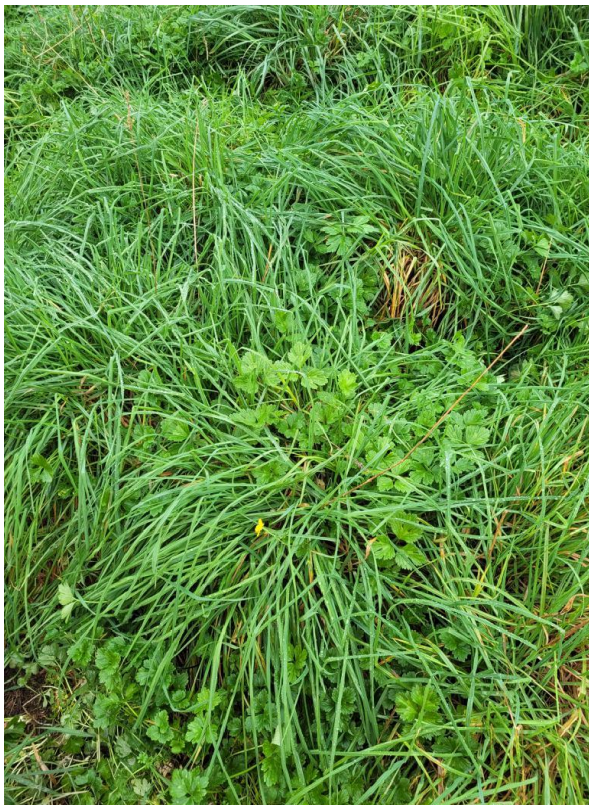
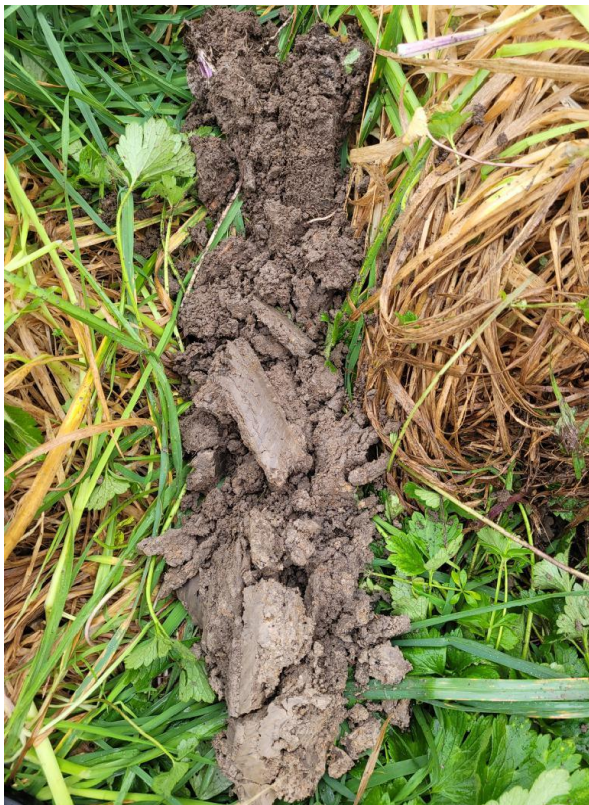
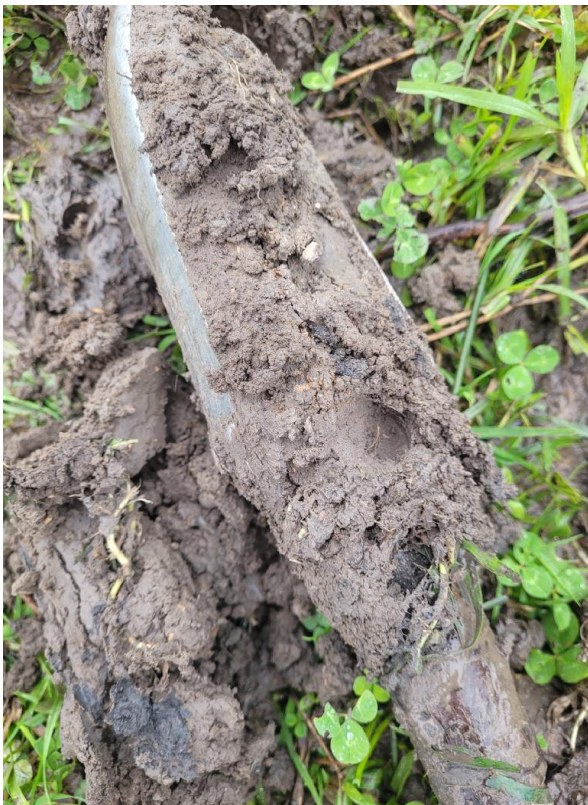
Figure 4f. Soil pits and vegetation plots conducting across the two wetland sites. Top left & bottom right: Plot 9, top right and bottom left: Plot 2.

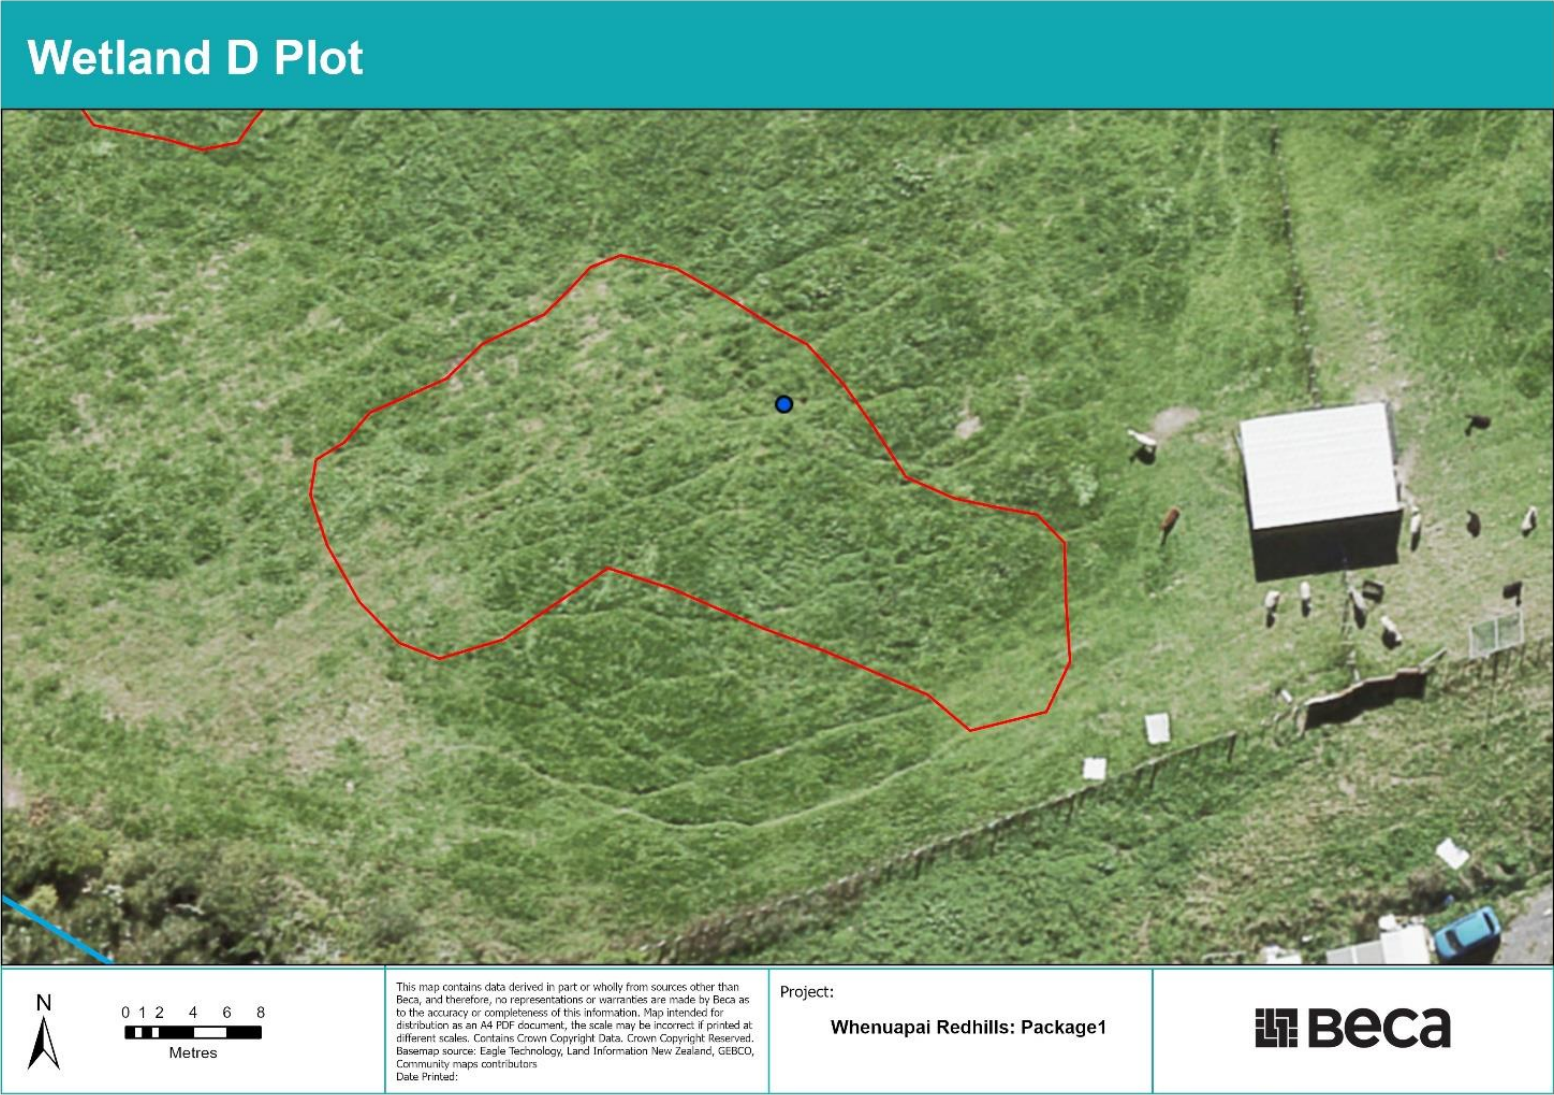
Figure 5a. Location of vegetation and soil plot (blue dot) within the identify vegetation boundary extent (red line) of Wetland D.

Wetland D was located at in a sloping area in the local landscape, and one wetland plot was undertaken at Wetland D in an area of representative vegetation types. Vegetation passed both the dominance and prevalence test (Table 5b), therefore immediately obtaining wetland status under the NPS-FM(2022). However, soils and hydrology tests were also undertaken to obtain further information to support the wetland status. Soils at the time of the site visit were highly wet, and although no surface water was present, water seepage into the soil pit was observed. The plot also passed the following hydrology indicators:

- 1B: groundwater < 30 cm
- 1C: soil saturation < 30 cm
- 4B: geomorphic position
