# Groundwater and Settlement Effects Report

Whenuapai Conveyance - Package 1

Tonkin & Taylor Ltd

October 2023

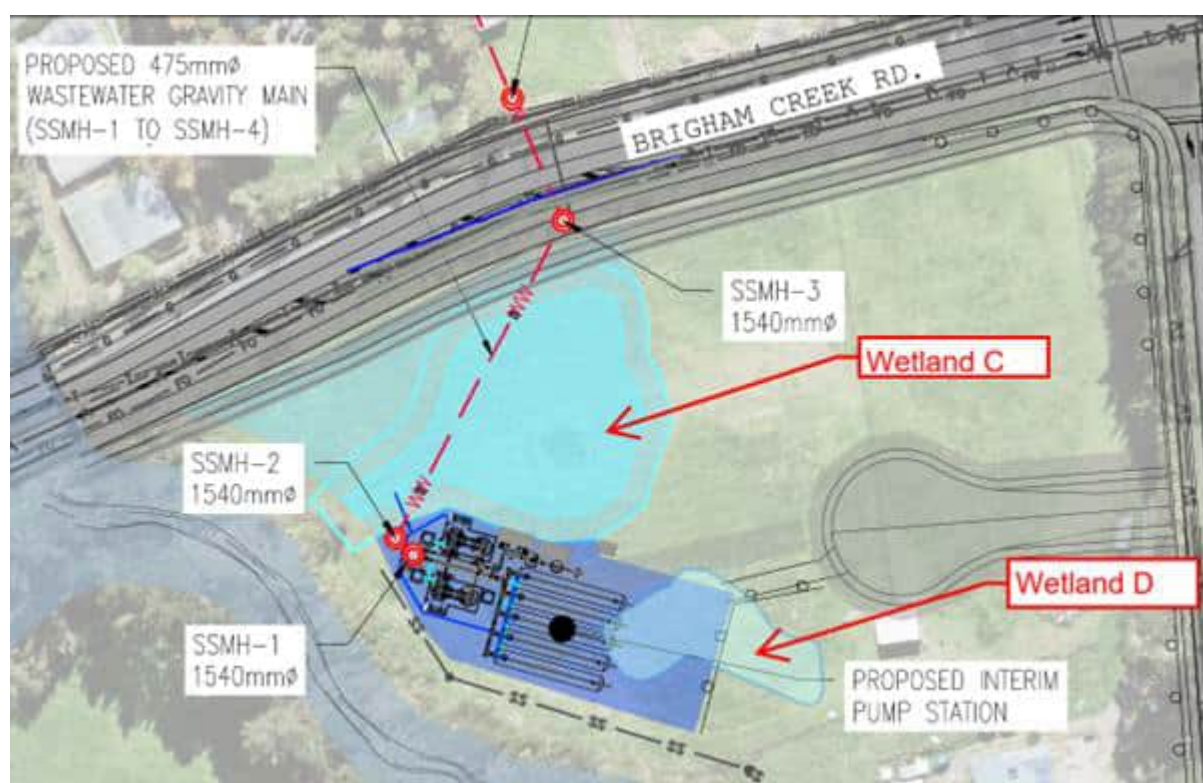
Figure 6.7: Pumpstation site plan showing approximate wetland extend

There are two wetlands located within the pump station site. Wetland C is located to the north of the proposed excavations, and Wetland D is located across the eastern portion of proposed excavation (Figure 6.7).

The proposed construction methodology allows for construction of a temporary sheet pile cut off wall between the excavation and Wetland C, and recharge to the Wetland C is to be undertaken to maintain hydrological conditions within the wetland to acceptable levels. The effects of Wetland C are expected to be monitored through the adaptive GSMCP and Wetland Monitoring and Reinstatement Plan provided as Appendix G of the Beca AEE with the possibility to adjust recharge rates accordingly. The effects of groundwater drawdown are presented in the Ecological Impact Assessment<sup>18</sup>, which is provided as Appendix C to the Beca AEE.

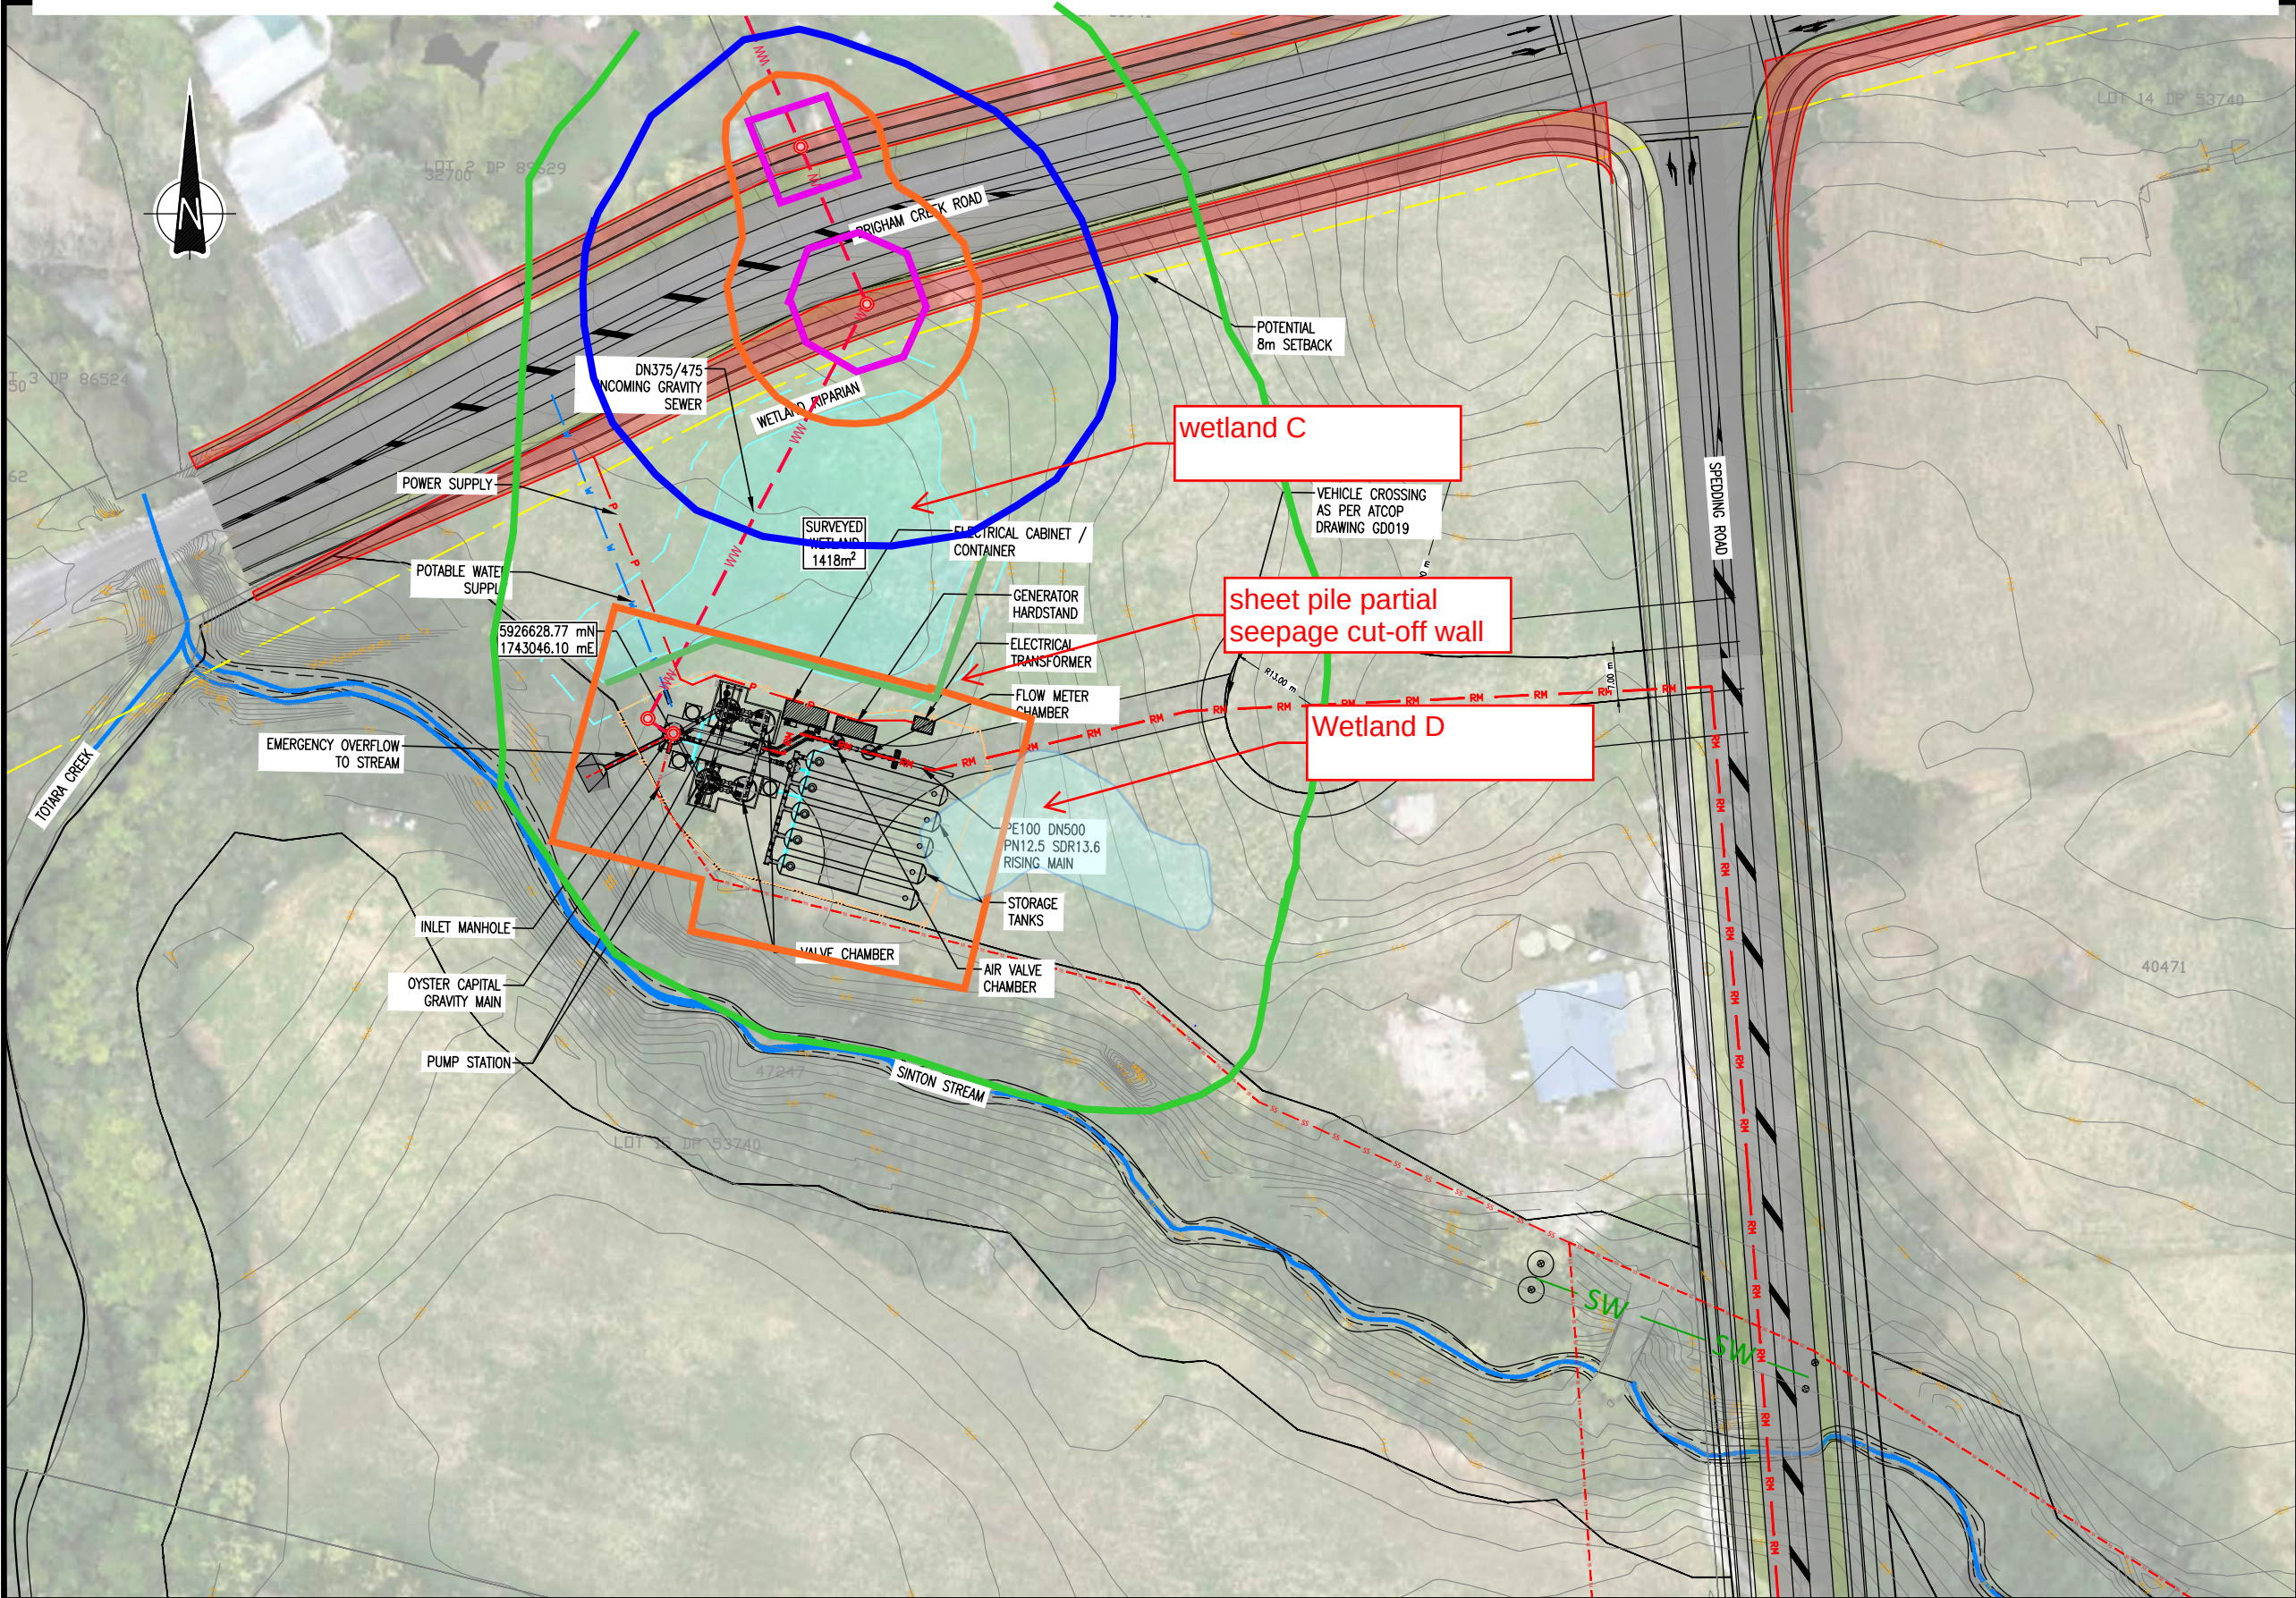
T+T MARK-UP WITH SURFACE GROUND SETTLEMENT CONTOURS ARISING FROM PROPOSED CONSTRUCTION WORKS

- EXISTING LOT BOUNDARY
- 8.00 EXISTING GROUND LEVEL
- 8.10 EXISTING GROUND LEVEL
- POTENTIAL SETBACK
- RM RISING MAIN
- P POWER SUPPLY
- SECURITY FENCE AND WSL OWNED
- W WATER SUPPLY
- WETLAND BOUNDARY
- STREAM
- WW WASTEWATER GRAVITY SEWER
- SS OYSTER CAPITAL GRAVITY SEWER (TBC)
- Approx 5mm settlement contour line
- Approx 10mm settlement contour line
- Approx 15mm settlement contour line
- Approx 20mm settlement contour line

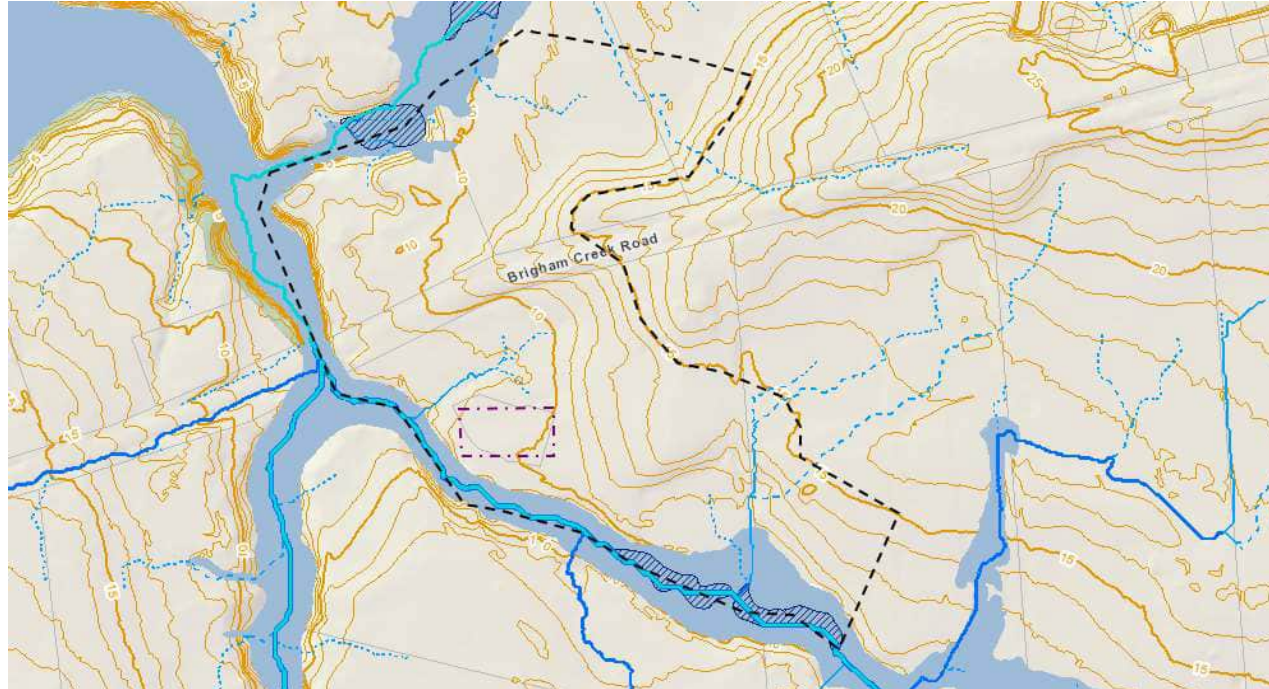
- The ground permeability model has been based on a fully saturated model which may result in higher water recharge rates than what is required.
- Modelling extents are shown in the figure below. The SEEP3D model lateral boundary extents are shown by the dashed black line. The purple dashed line indicates the approximate location of the proposed pump station

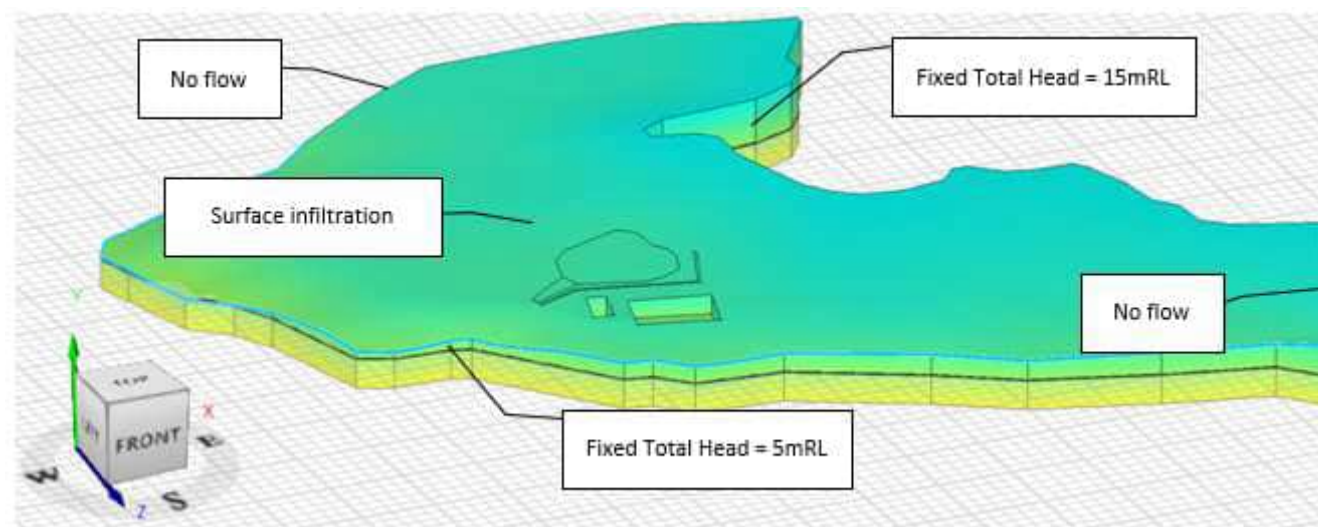
- The ground surface has been modelled as a 3D surface within SEEP3D based on ground elevation contour information. The north-eastern boundary approximately follows the 15 mRL elevation contour, and the south-western boundary follows the stream. The 'side' boundaries have been selected to be approximately perpendicular to the ground elevation contours.
- The hydraulic boundary conditions assumed are presented below:
  - Fixed Total Head = 15 mRL at the uphill boundary face. This is based on an assumed winter phreatic surface at ground level.
  - Fixed Total Head = 5 mRL along the stream boundary. This is based on estimated stream invert level from the ground level contour plan.
  - Surface infiltration rate applied to the ground surface equal to 5% of average annual rainfall ( $5\% \times 1380$  mm/year =  $2.19 \times 10^{-9}$  m/s).
  - 'No flow' boundary along model 'sides'.

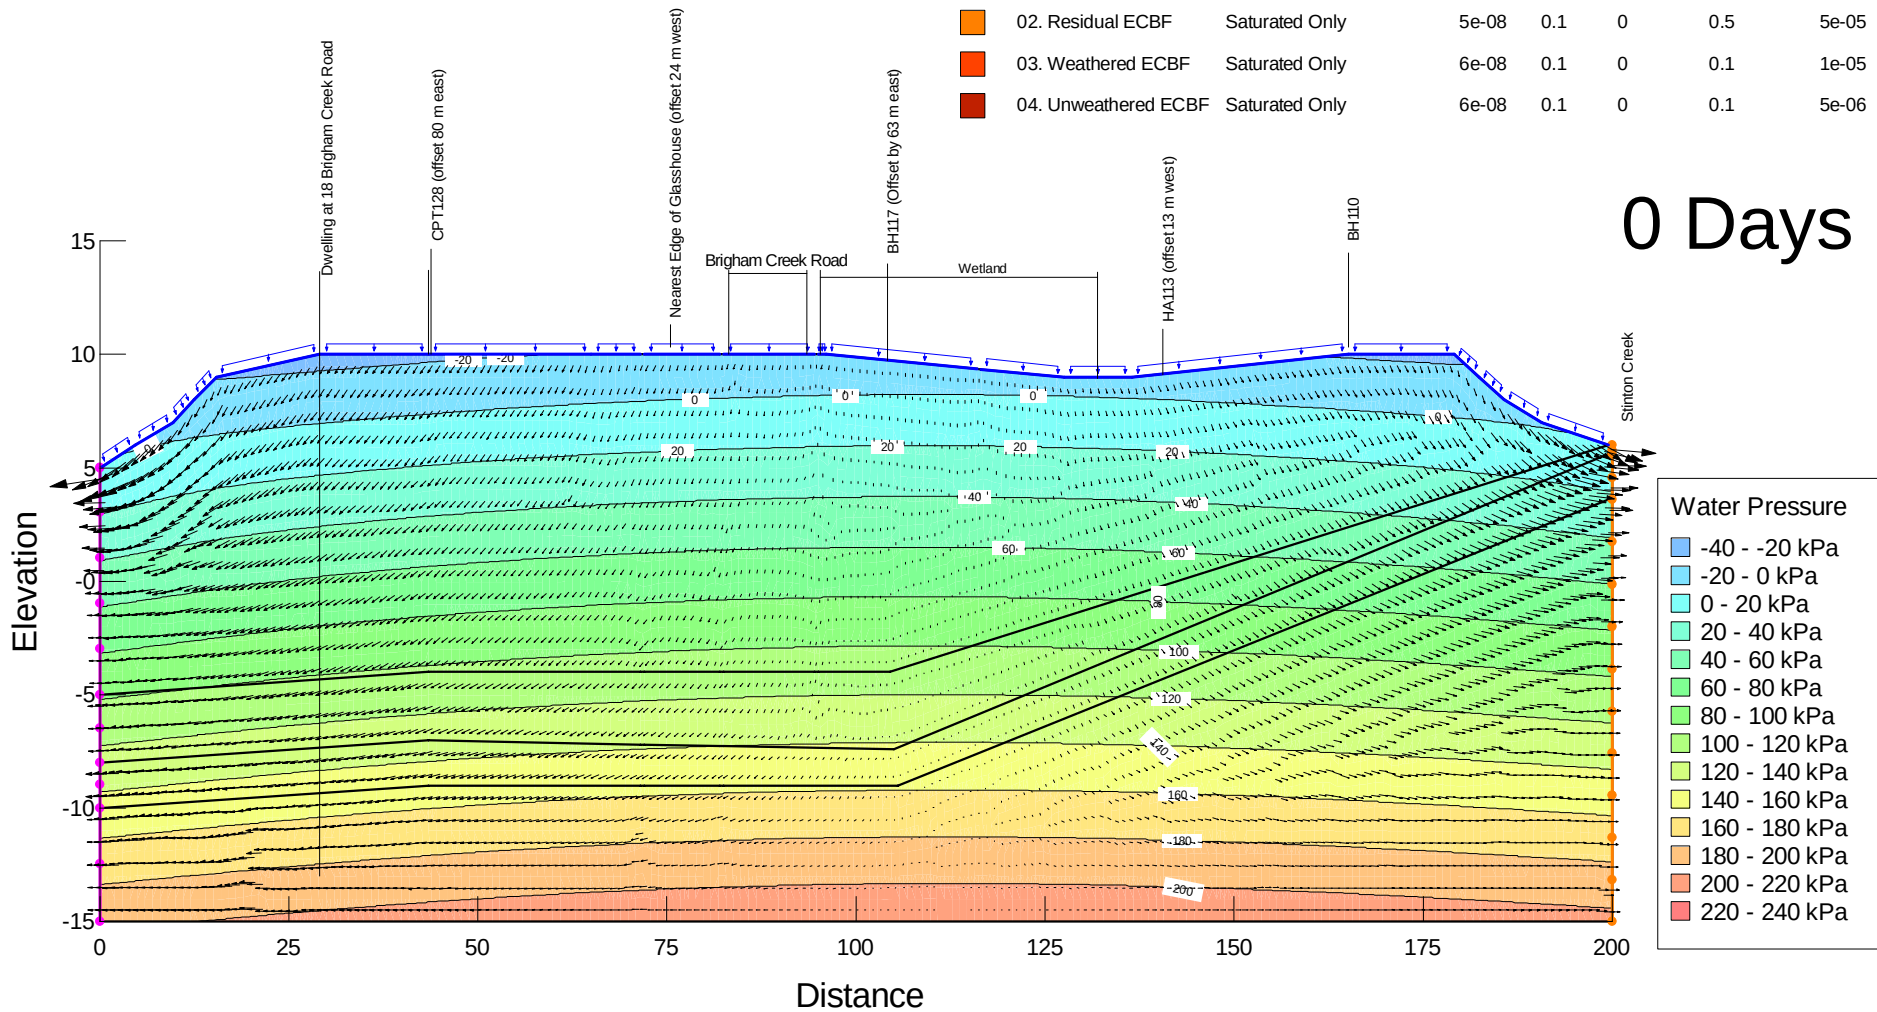
Analysis Notes:  
1. Name: 3.2 Reception Shaft Excavation  
2. Method: Transient

0 Days

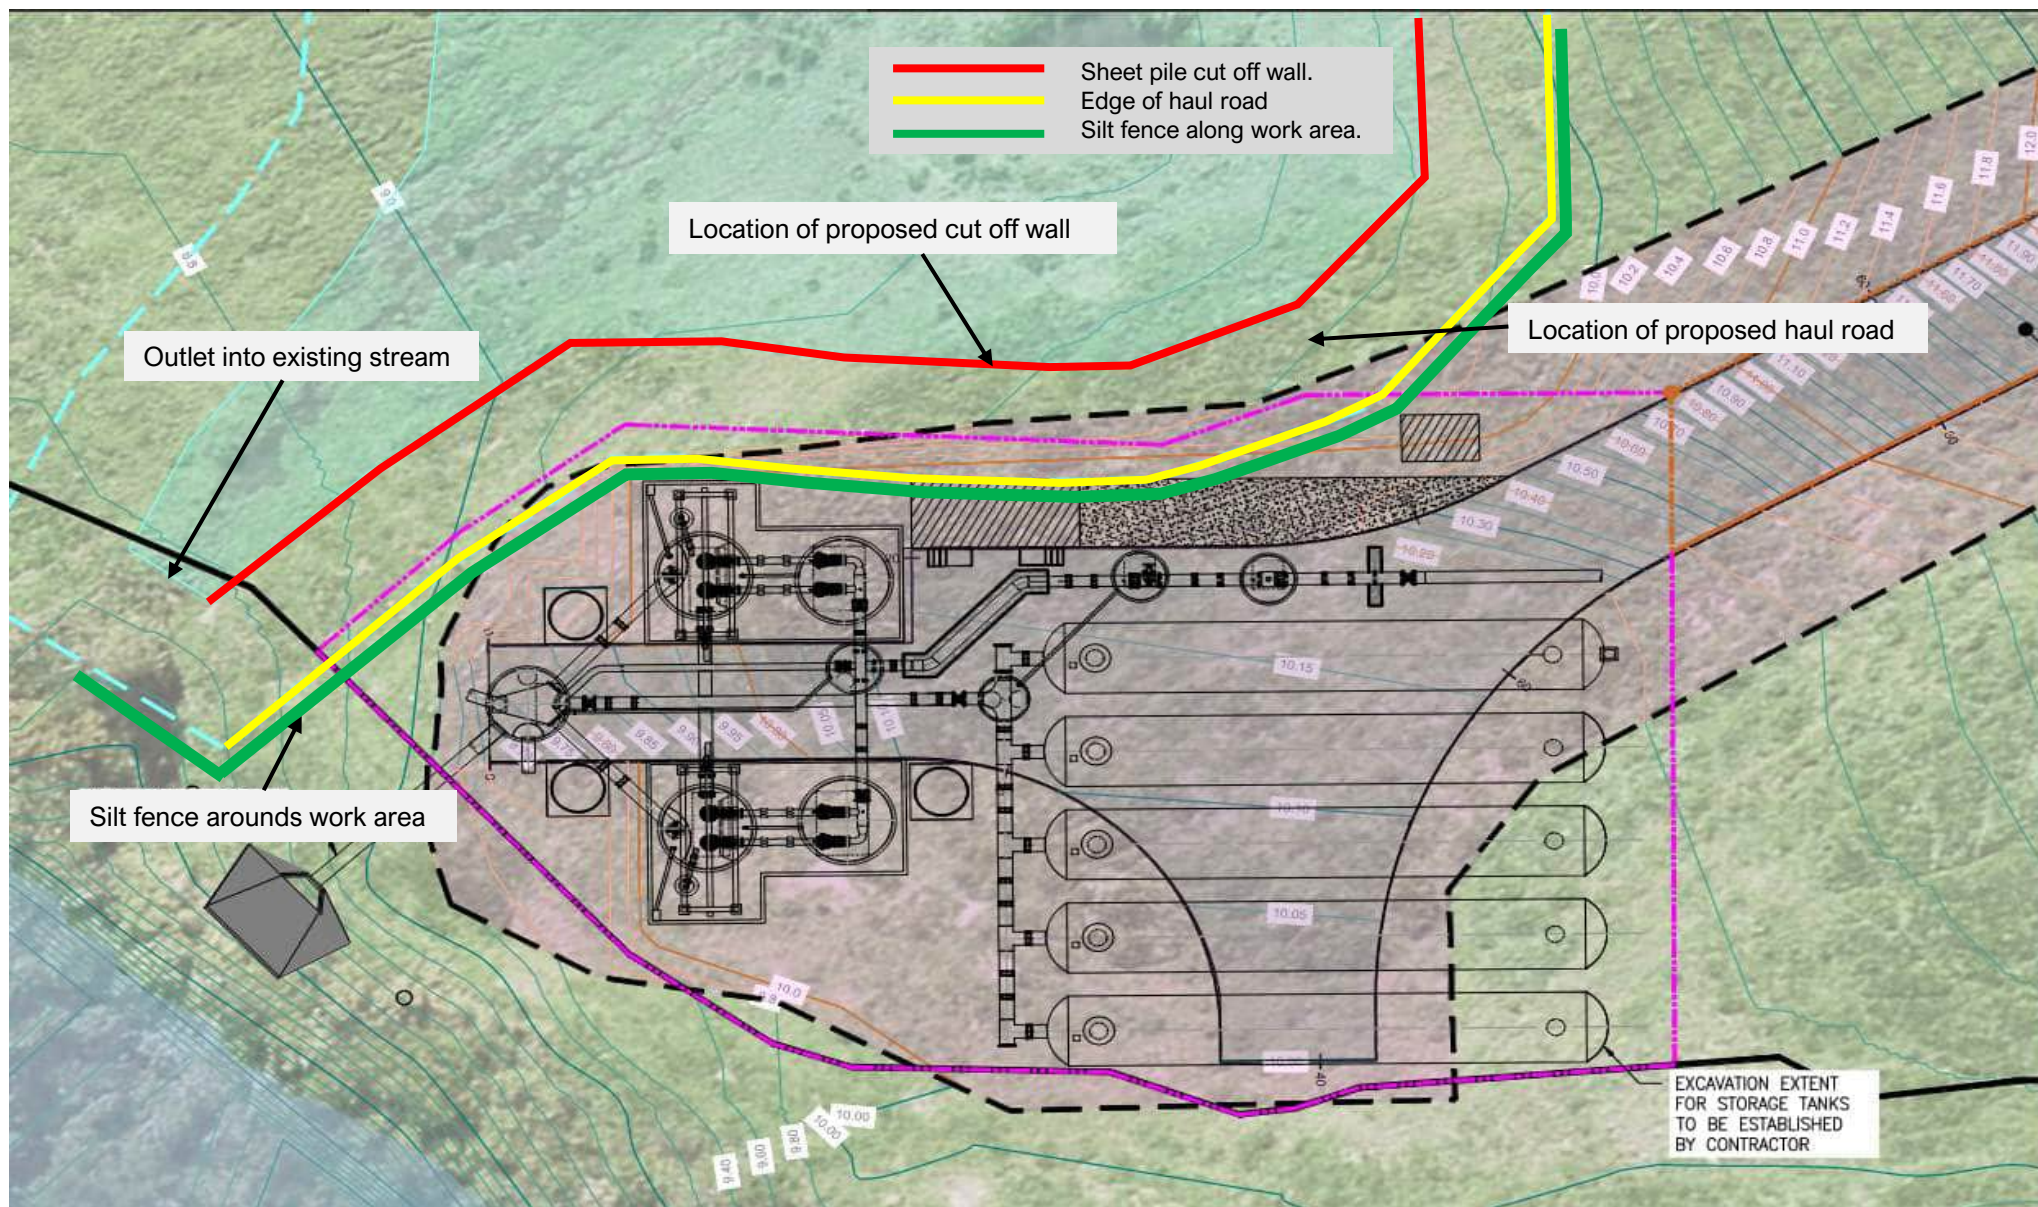
#### Mark out location of sheet pile cut off wall.

- Agree the outline of the Wet lands area including run off area towards the existing stream.
- Install silt fence along the edge of the proposed haul road.

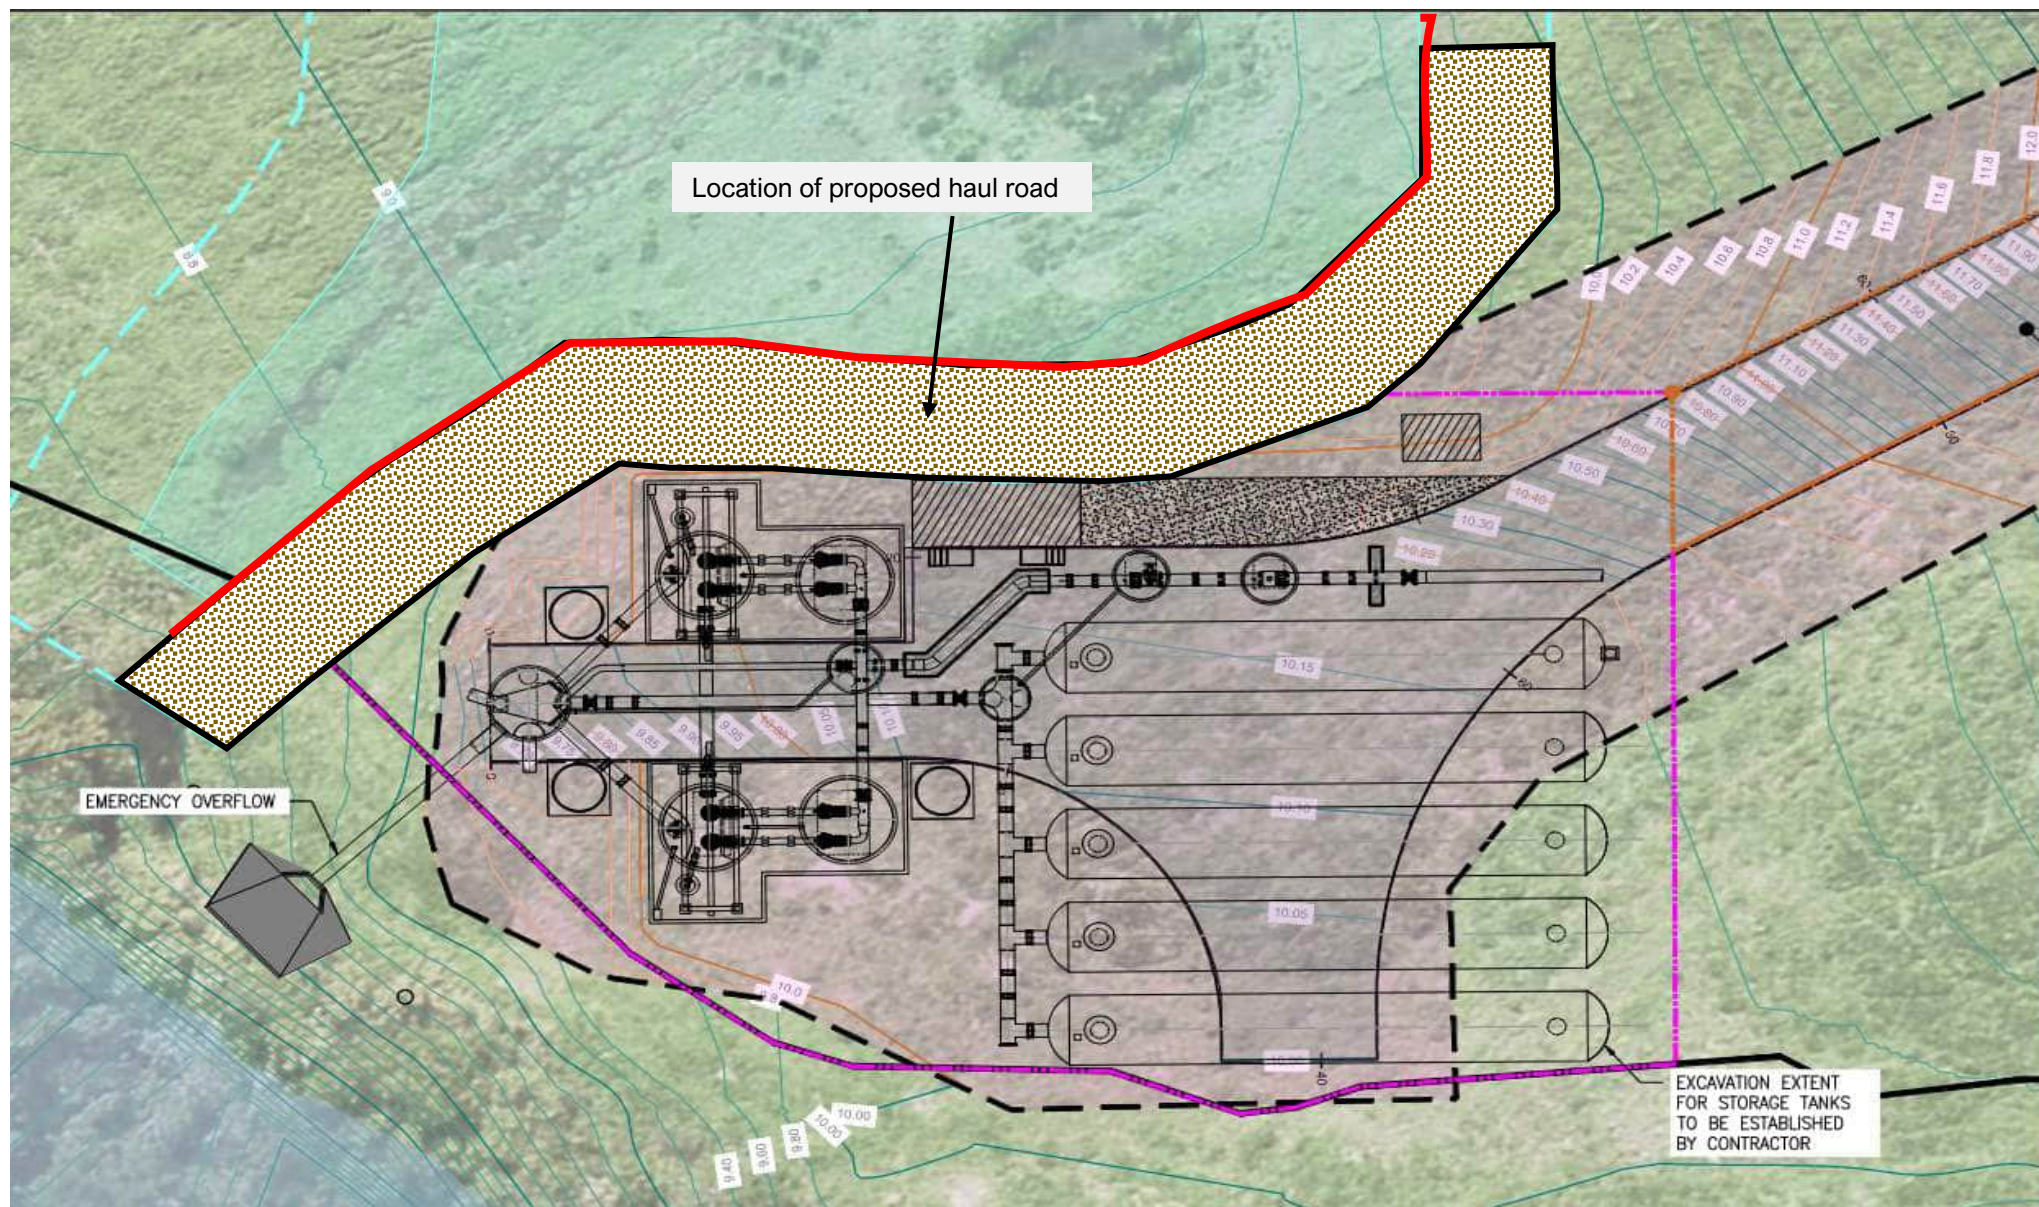
#### Placement of haul road.

- To construct the haul road, the existing top soil will be removed and stockpiled for reinstatement, after all works are completed.
- Bidum cloth will be placed over exposed ground, next a 200mm layer of compacted hard fill will placed onto of cloth.
- Then a layer of geo-grid will be placed on top of the existing hardfill and a final 200mm layer of compacted hard fill will be placed on top of geogrid.

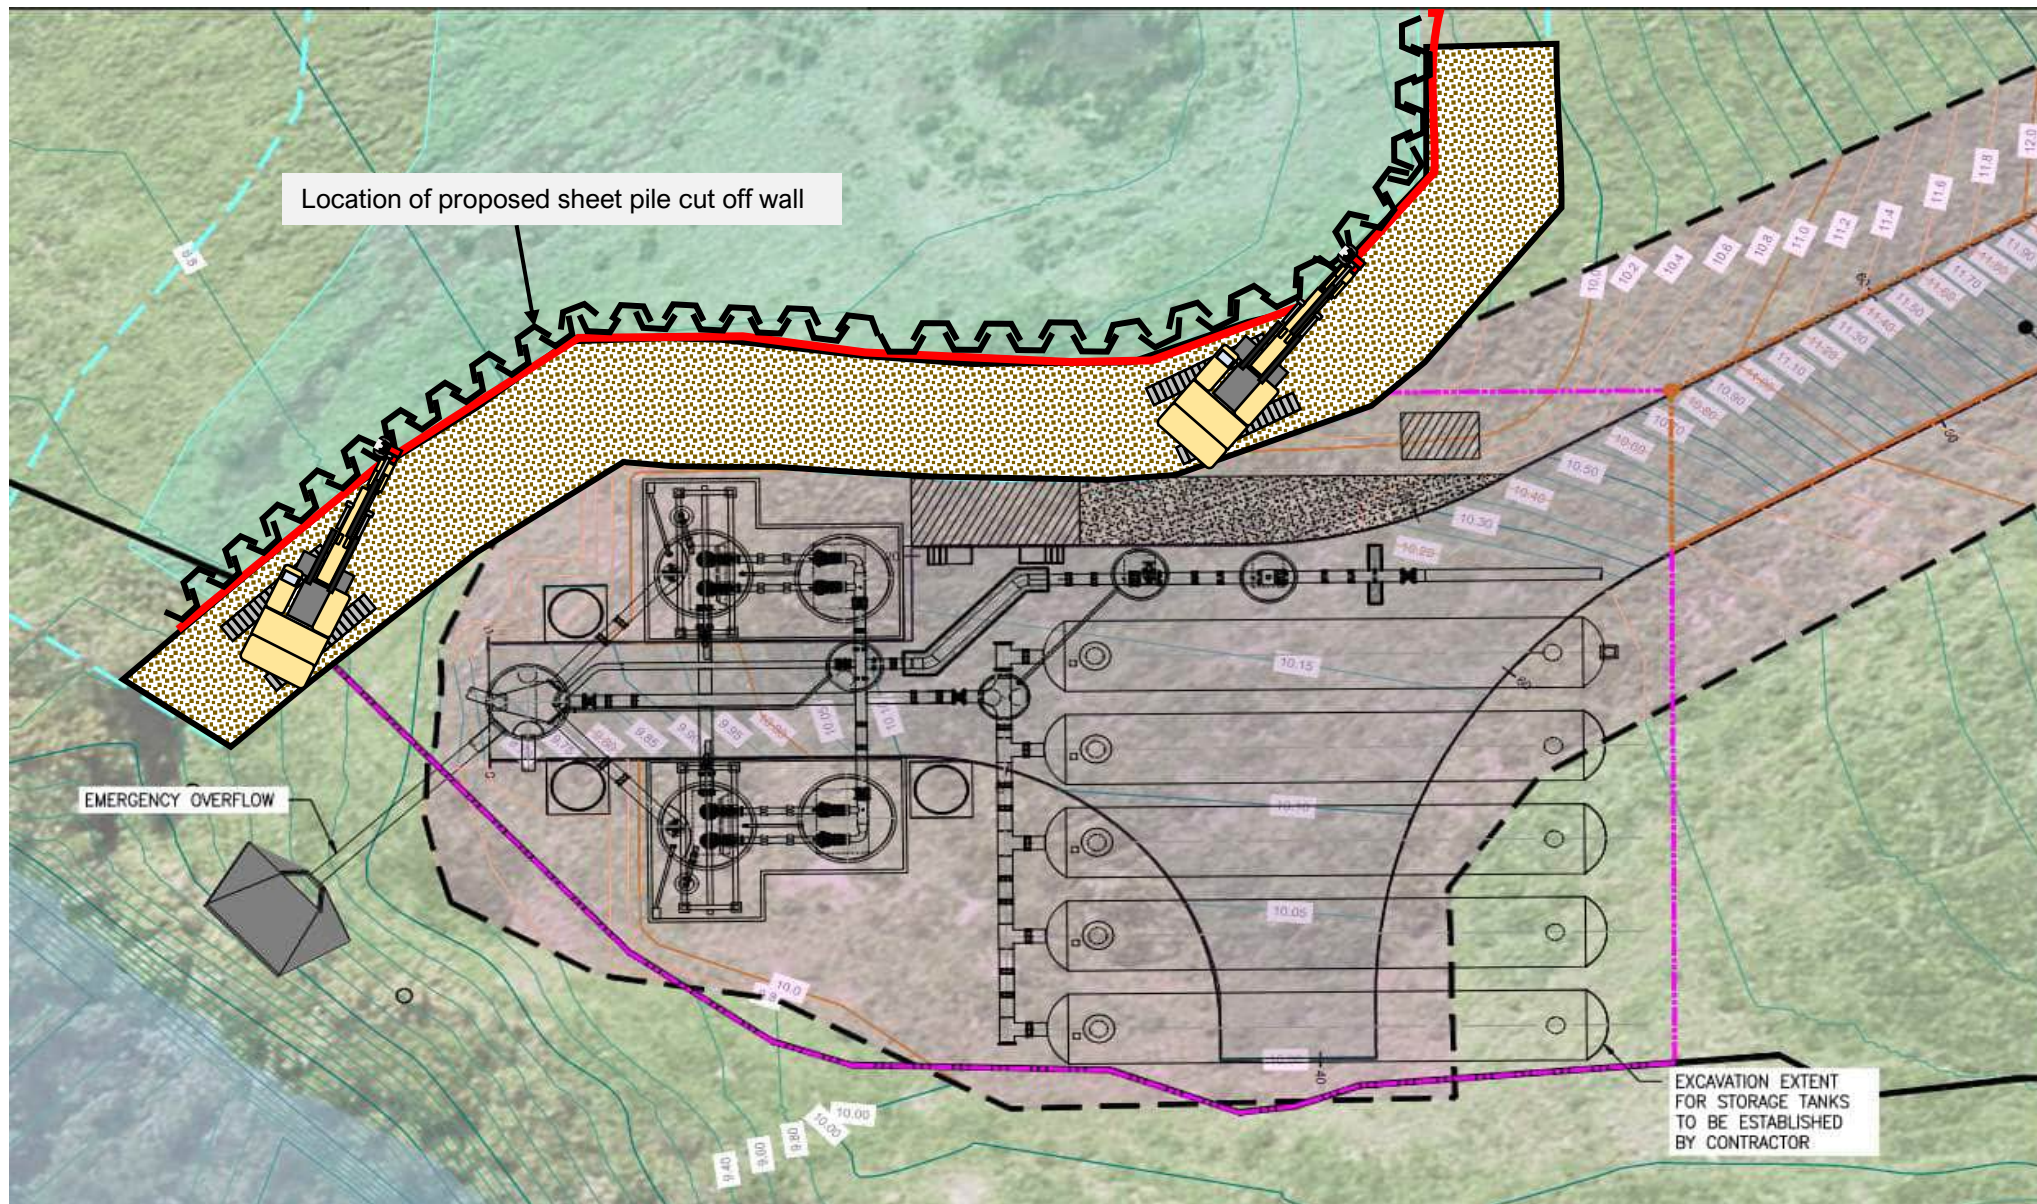
#### Installation of sheet pile cut off wall.
