# BOREHOLE LOG

**BH117**

PROJECT: Watercare Whenuapai-Redhill GI  
JOB No.: 1014985.0000  
LOCATION: Whenuapai

# CORE PHOTOS

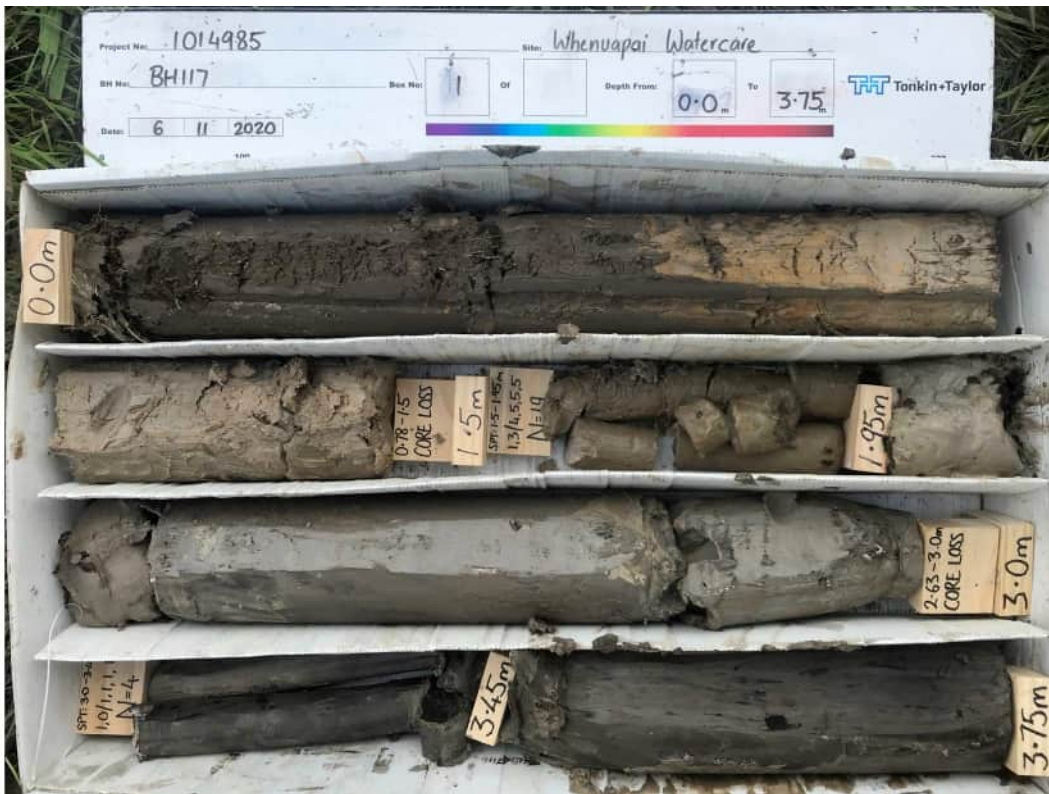
0.00-3.75m

| GEOLOGICAL UNIT | DESCRIPTION OF CORE | Rock Weathering | Rock Strength | Sampling Method | Core Recovery (%) | Testing | RL (m) | Depth (m) | Graphic Log | ROCK DEFECTS | | | | Fluid Loss (%) | Water Level | Casing | Installation | Core Box No |
|---|---|---|---|---|---|---|---|---|---|---|---|---|---|---|---|---|---|---|
| | Sandy SILT, trace organics; dark brown. Firm, saturated, low plasticity; Sand, fine; organics, rootlets [TOPSOIL]. | | | | | 2 @ 0.10m | | | | | | | | | | | | |
| Tauranga Group | Sandy SILT, some clay, trace organics; Brown mottled orange. Stiff, moist, moderate plasticity; Sand, fine; organics, rootlets<br>0.55m: Brown mottled orange speckled white | | | PQTT | 52 | 3 @ 0.50m | | 0.5 | | | | | | | | | | |
| | Silty fine grained SAND, minor organics; brown-grey. Medium dense, moist, poorly graded; organics, wood. | | | SPT | 84 | 1/3<br>4/5<br>5/5<br>N=19 | | 1.5 | | | | | | | | | | |
| | Clayey SILT, minor sand, trace organics; grey-brown speckled black. Stiff, moist, moderate plasticity; Sand, fine; organics, rootlets | | | PQTT | 64 | 4 @ 2.00m | | 2.0 | | | | | | | | | | |

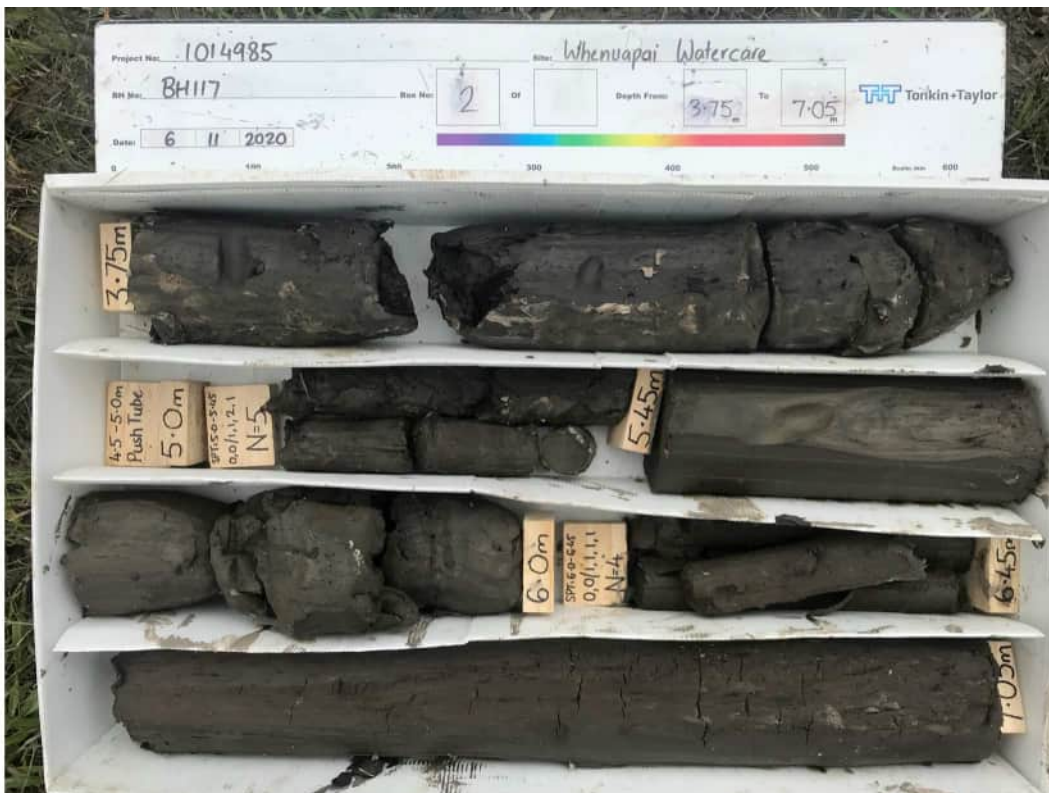
3.75-7.05m

| GEOLOGICAL UNIT | DESCRIPTION OF CORE | Rock Weathering | Rock Strength | Sampling Method | Core Recovery (%) | Testing | RL (m) | Depth (m) | Graphic Log | ROCK DEFECTS | | | | Fluid Loss (%) | Water Level | Casing | Installation | Core Box No |
|---|---|---|---|---|---|---|---|---|---|---|---|---|---|---|---|---|---|---|
| | Organic SILT, some clay, trace organics; dark grey - brown. Stiff, moist, low plasticity; organics, wood. | | | SPT | 100 | 5 @ 3.00m<br>1/1<br>1/1<br>N=4 | | 3.0 | | | | | | | | | | |
| | Grades to: Organic Clayey SILT, trace organics; dark grey-brown. Stiff, moist, low plasticity; organics, wood. | | | PQTT | 83 | 6 @ 4.00m | | 4.0 | | | | | | | | | | |
| | 4.5 - 5.0m: PUSH TUBE | | | PT | 0 | 1 @ 4.50m | | 4.5 | | | | | | | | | | |

| GEOLOGICAL UNIT | DESCRIPTION OF CORE | Rock Weathering | Rock Strength | Sampling Method | Core Recovery (%) | Testing | RL (m) | Depth (m) | Graphic Log | ROCK DEFECTS | | | | Fluid Loss (%) | Water Level | Casing | Installation | Core Box No |
|---|---|---|---|---|---|---|---|---|---|---|---|---|---|---|---|---|---|---|
| Tauranga Group | Organic Clayey SILT; dark grey-brown. Stiff, moist, low plasticity; organics, wood.<br>5.20m: grey-brown, mottled brown speckled black | | | SPT | 100 | 7 @ 5.00m<br>0/0<br>1/1<br>2/1<br>N=5 | | 5.5 | | | | | | | | | | |

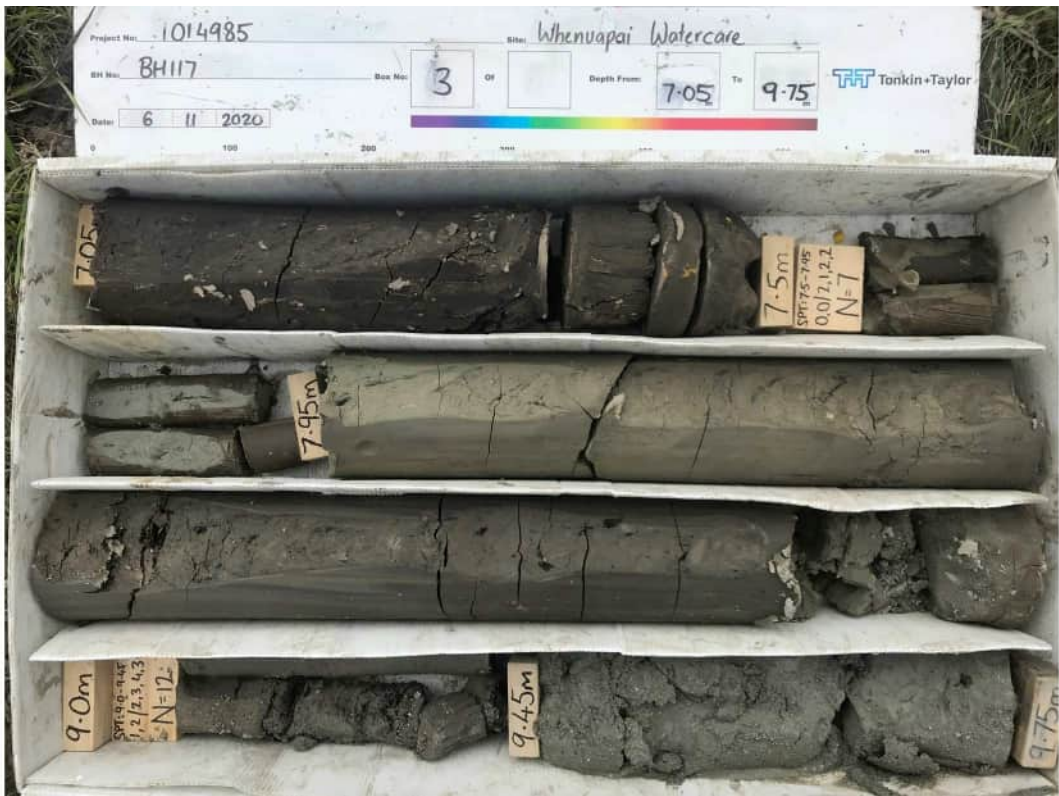
7.05-9.75m

| GEOLOGICAL UNIT | DESCRIPTION OF CORE | Rock Weathering | Rock Strength | Sampling Method | Core Recovery (%) | Testing | RL (m) | Depth (m) | Graphic Log | ROCK DEFECTS | | | | Fluid Loss (%) | Water Level | Casing | Installation | Core Box No |
|---|---|---|---|---|---|---|---|---|---|---|---|---|---|---|---|---|---|---|
| | 7.10m: Grades: grey-brown | | | PQTT | 100 | | | 7.5 | | | | | | | | | | |
| | Sandy SILT, trace organics; light grey-green, speckled black. Stiff, moist, low plasticity; Sand, fine; organics, fibrous | | | SPT | 100 | 0/0<br>2/1<br>2/2<br>N=7 | | 8.0 | | | | | | | | | | |
| | 8.10m: Grades: grey-brown, mottled brown, speckled black | | | | | | | 8.5 | | | | | | | | | | |
| | 8.90 - 9.00m: Fine to medium grained SAND; grey. Medium dense, moist, poorly graded. | | | | | | | 9.0 | | | | | | | | | | |
| | Sandy SILT, trace organics; grey speckled black. Stiff, moist, low plasticity; Sand, fine; organics, fibrous<br>9.28 - 9.29m: Wood (10mm)<br>9.34 - 9.35m: Wood (10mm) | | | SPT | 100 | 1/2<br>2/3<br>4/3<br>N=12 | | 9.5 | | | | | | | | | | |

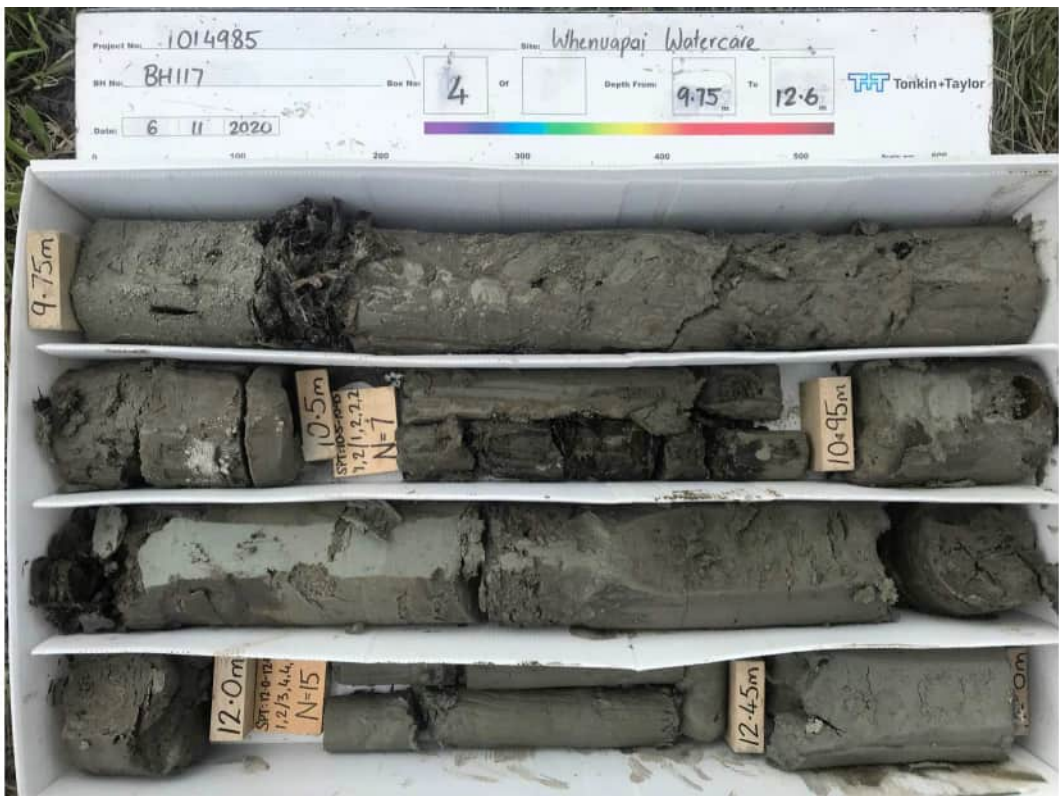
9.75-12.60m

| GEOLOGICAL UNIT | DESCRIPTION OF CORE | | Rock Weathering | Rock Strength | Sampling Method | Core Recovery (%) | Testing | RL (m) | Depth (m) | Graphic Log | ROCK DEFECTS | | | | Fluid Loss (%) | Water Level | Casing | Installation | Core Box No |
|---|---|--|---|---|---|---|---|---|---|---|---|---|---|---|---|---|---|---|---|
| | Fine SAND, some silt, some organics; grey. Loose, moist, poorly graded; organics, wood<br>9.75 - 9.80m: Wood | | | | | | | | 10.5 | | | | | | | | | | |
| | Clayey SILT, trace organics; light green. Stiff, moist, moderate plasticity; organics, fibrous.<br>10.34 - 10.39m: Wood | | | | SPT | 113 | 1/2<br>1/2<br>2/2<br>N=7 | | | | | | | | | | | | |
| | Sandy SILT, some clay, trace organics; light grey-green. Stiff, moist, low plasticity; organics, fibrous.<br>10.40m: brown | | | | | | | | 11.0 | | | | | | | | | | |
| | Silty SAND, trace organics; brown mottled grey. Medium dense, moist, poorly graded; sand, fine; organics, fibrous.<br>11.03 - 11.07m: Wood | | | | PQTT | 80 | | | 11.5 | | | | | | | | | | |
| | Silty SAND, some clay, trace organics; brown. Medium dense, moist, poorly graded; sand, fine; organics, wood. | | | | SPT | 108 | 1/2<br>3/4<br>4/4<br>N=15 | | 12.0 | | | | | | | | | | |

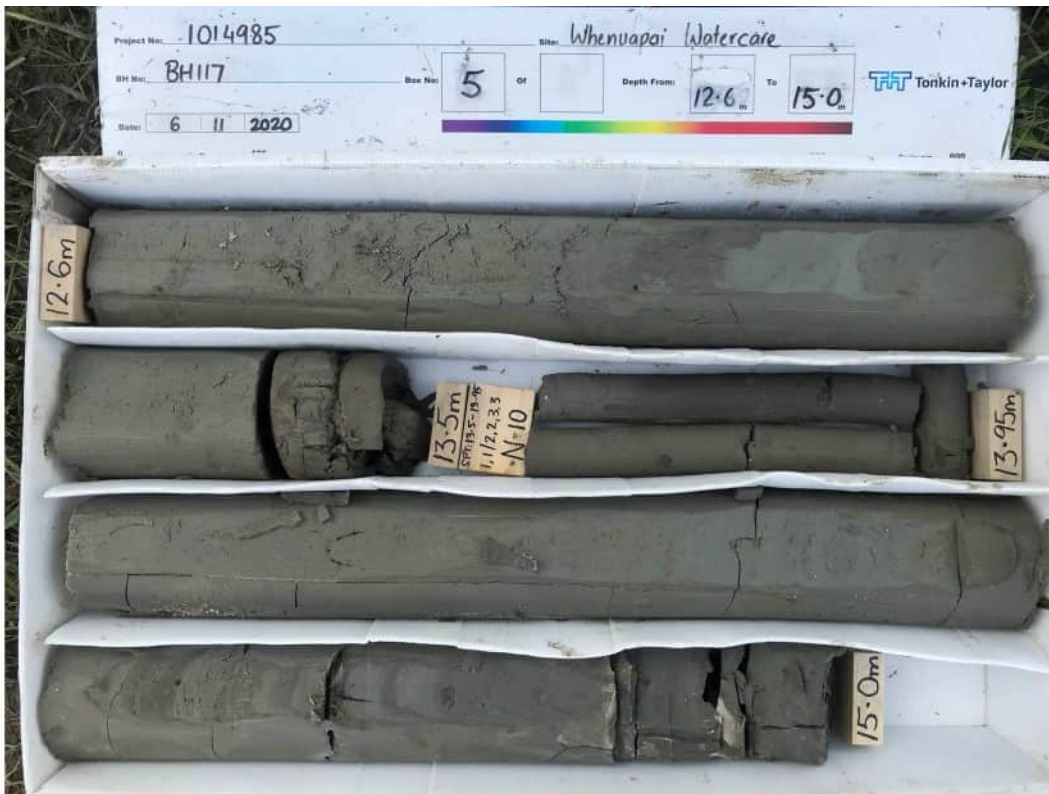
12.60-15.00m

| GEOLOGICAL UNIT | DESCRIPTION OF CORE | | Rock Weathering | Rock Strength | Sampling Method | Core Recovery (%) | Testing | RL (m) | Depth (m) | Graphic Log | ROCK DEFECTS | | | | Fluid Loss (%) | Water Level | Casing | Installation | Core Box No |
|---|---|--|---|---|---|---|---|---|---|---|---|---|---|---|---|---|---|---|---|
| | Grades to: Sandy SILT, minor clay, trace organics; grey. Very stiff, moist, low plasticity; Sand, fine; organics, wood | | | | PQTT | 90 | | | 13.0 | | | | | | | | | | |
| | 13.50m: Grey & brown, speckled black | | | | SPT | 124 | 1/1<br>2/2<br>3/3<br>N=10 | | 13.5 | | | | | | | | | | |
| | 13.90m: Grey | | | | | | | | 14.0 | | | | | | | | | | |
| | Sandy SILT, some clay, trace organics. Grey & brown speckled black. Very stiff, moist, low plasticity; Sand, fine; organics, carbonaceous. | | | | PQTT | 100 | | | 14.5 | | | | | | | | | | |

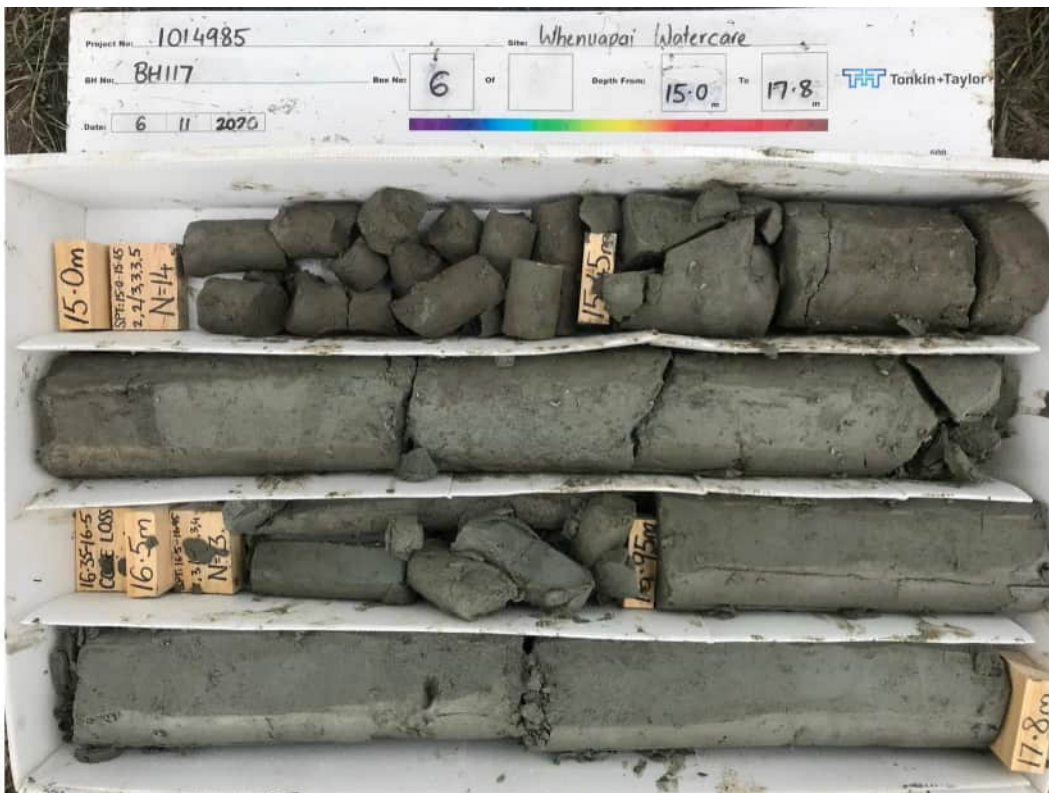
15.00-17.80m

| GEOLOGICAL UNIT | DESCRIPTION OF CORE | | Rock Weathering | Rock Strength | Sampling Method | Core Recovery (%) | Testing | RL (m) | Depth (m) | Graphic Log | ROCK DEFECTS | | | | Fluid Loss (%) | Water Level | Casing | Installation | Core Box No |
|---|---|--|---|---|---|---|---|---|---|---|---|---|---|---|---|---|---|---|---|
| East Coast Bays Formation | Sandy SILT, some clay, trace carbonaceous. Grey & brown speckled black. Very stiff, moist, low plasticity; Sand, fine | | | | SPT | 144 | 2/2<br>3/3<br>3/5<br>N=14 | | | | | | 0 | | | | | | |
| | Fine to medium grained SAND, some silt, trace carbonaceous; light green & brown. Medium dense, moist, poorly graded | | | | PQTT | 85 | | | 15.5 | | | | 0 | | | | | | |
| | 16.35 - 16.5m: Core Loss | | | | | | | | | | | | | | | | | | |
| | Sandy SILT, some clay, trace carbonaceous light green. Stiff, moist, low plasticity; Sand, fine | | | | SPT | 128 | 2/3<br>2/4<br>3/4<br>N=13 | | | | | | 0 | | | | | | |
| | Fine SAND, some silt, trace carbonaceous; light green - grey. Loosely packed, moist, poorly graded | | | | PQTT | 80 | | | 17.0 | | | | 0 | | | | | | |

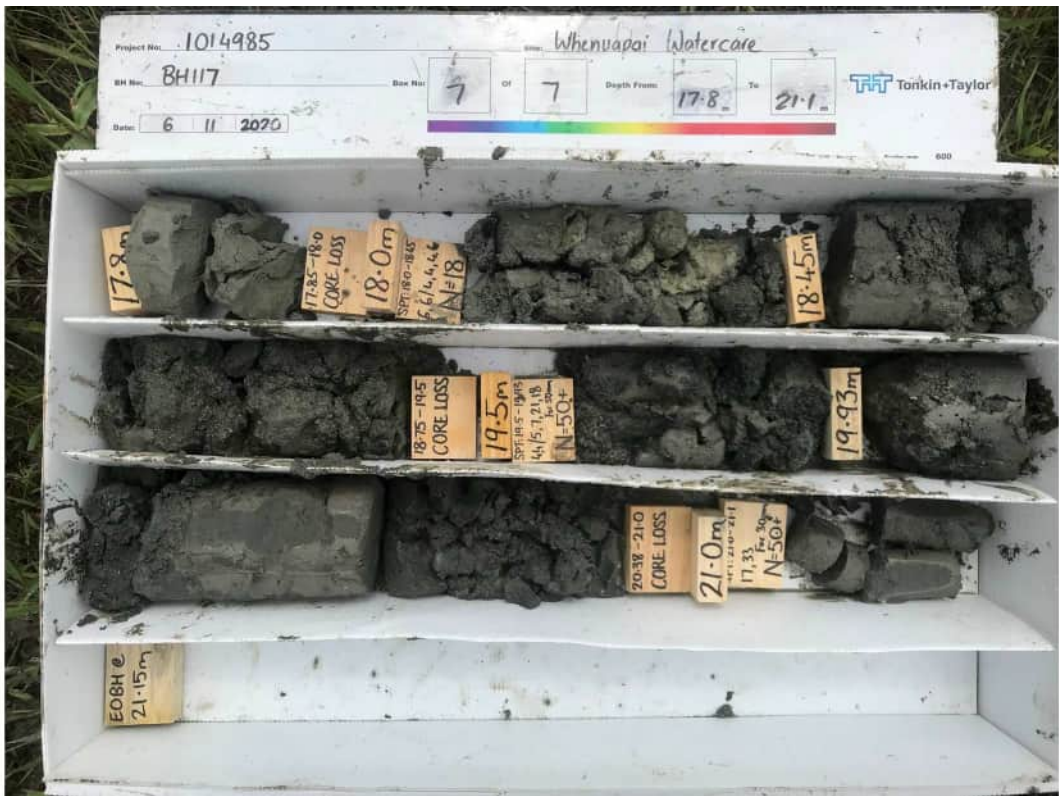
17.80-21.15m

| GEOLOGICAL UNIT | DESCRIPTION OF CORE | | Rock Weathering | Rock Strength | Sampling Method | Core Recovery (%) | Testing | RL (m) | Depth (m) | Graphic Log | ROCK DEFECTS | | | | Fluid Loss (%) | Water Level | Casing | Installation | Core Box No |
|---|---|--|---|---|---|---|---|---|---|---|---|---|---|---|---|---|---|---|---|
| | 18.10 - 18.14m: Wood (40mm) | | | | | | | | | | | | | | | | | | |
| | Slight weathered, brown, fine grained SANDSTONE; Very weak | | | | SPT | 100 | 6/6<br>4/4<br>4/6<br>N=18 | | | | | | 0 | | | | | | |
| | Highly weathered, grey-green speckled white, coarse, SANDSTONE. Extremely Weak, (Recovered as fine to coarse SAND, minor gravel; grey-green speckled white, red, brown & green. Medium dense, moist, poorly graded). | | | | | | | | | | | | | | | | | | |
| 18.75 - 19.5m: Core Loss | | | | PQTT | 28 | | | | | | | 0 | | | | | | | |
| Highly weathered, grey-green speckled white, red, brown & green, coarse, SANDSTONE. Extremely Weak, (Recovered as Fine to coarse SAND, minor gravel; grey-green speckled white, red, brown & green. Very dense, moist, poorly graded). | | | | SPT | 77 | 4/4<br>5/7<br>21/18 for 50mm<br>N>=50 | | | | | | 0 | | | | | | | |
